# JELLINBAH COAL MINE RECEIVING ENVIRONMENT MONITORING PROGRAM EPML00516813 2026 PROGRESS REPORT

PREPARED FOR  
JELLINBAH MINING PTY LTD

April 2026

| <b>Report Title:</b> | Receiving Environment Monitoring Program (REMP): 2026 Progress Report |

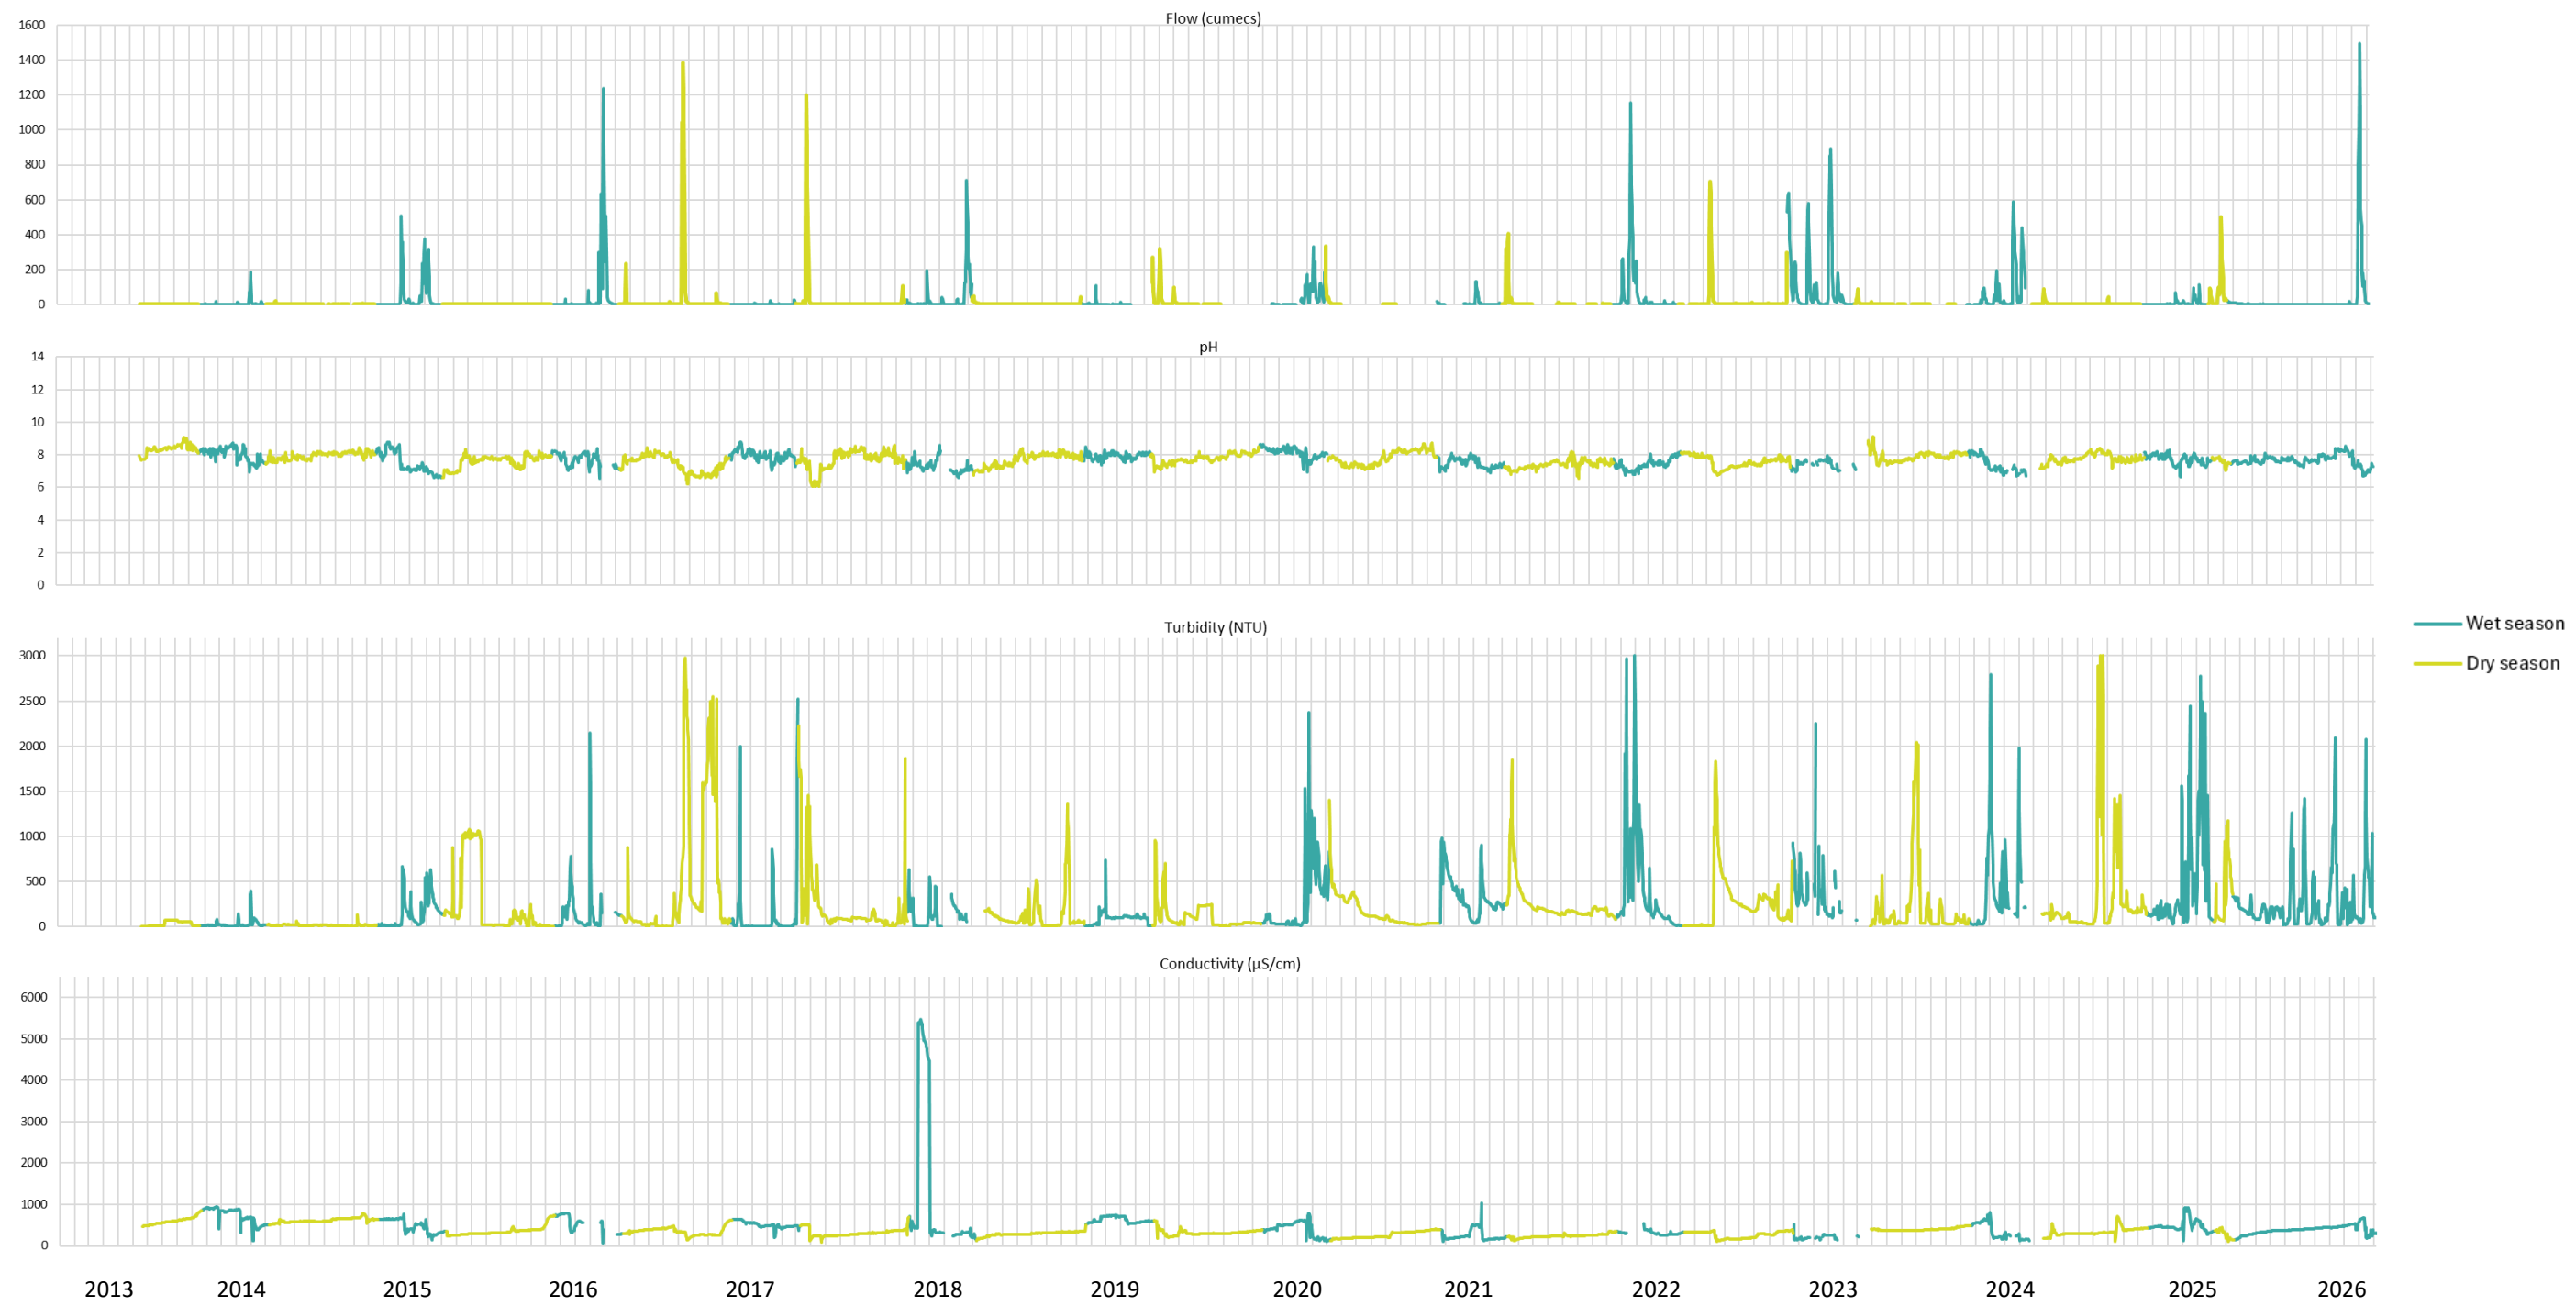
Figure 5-5: Historical continuous data from Mackenzie River gauging station (331423)

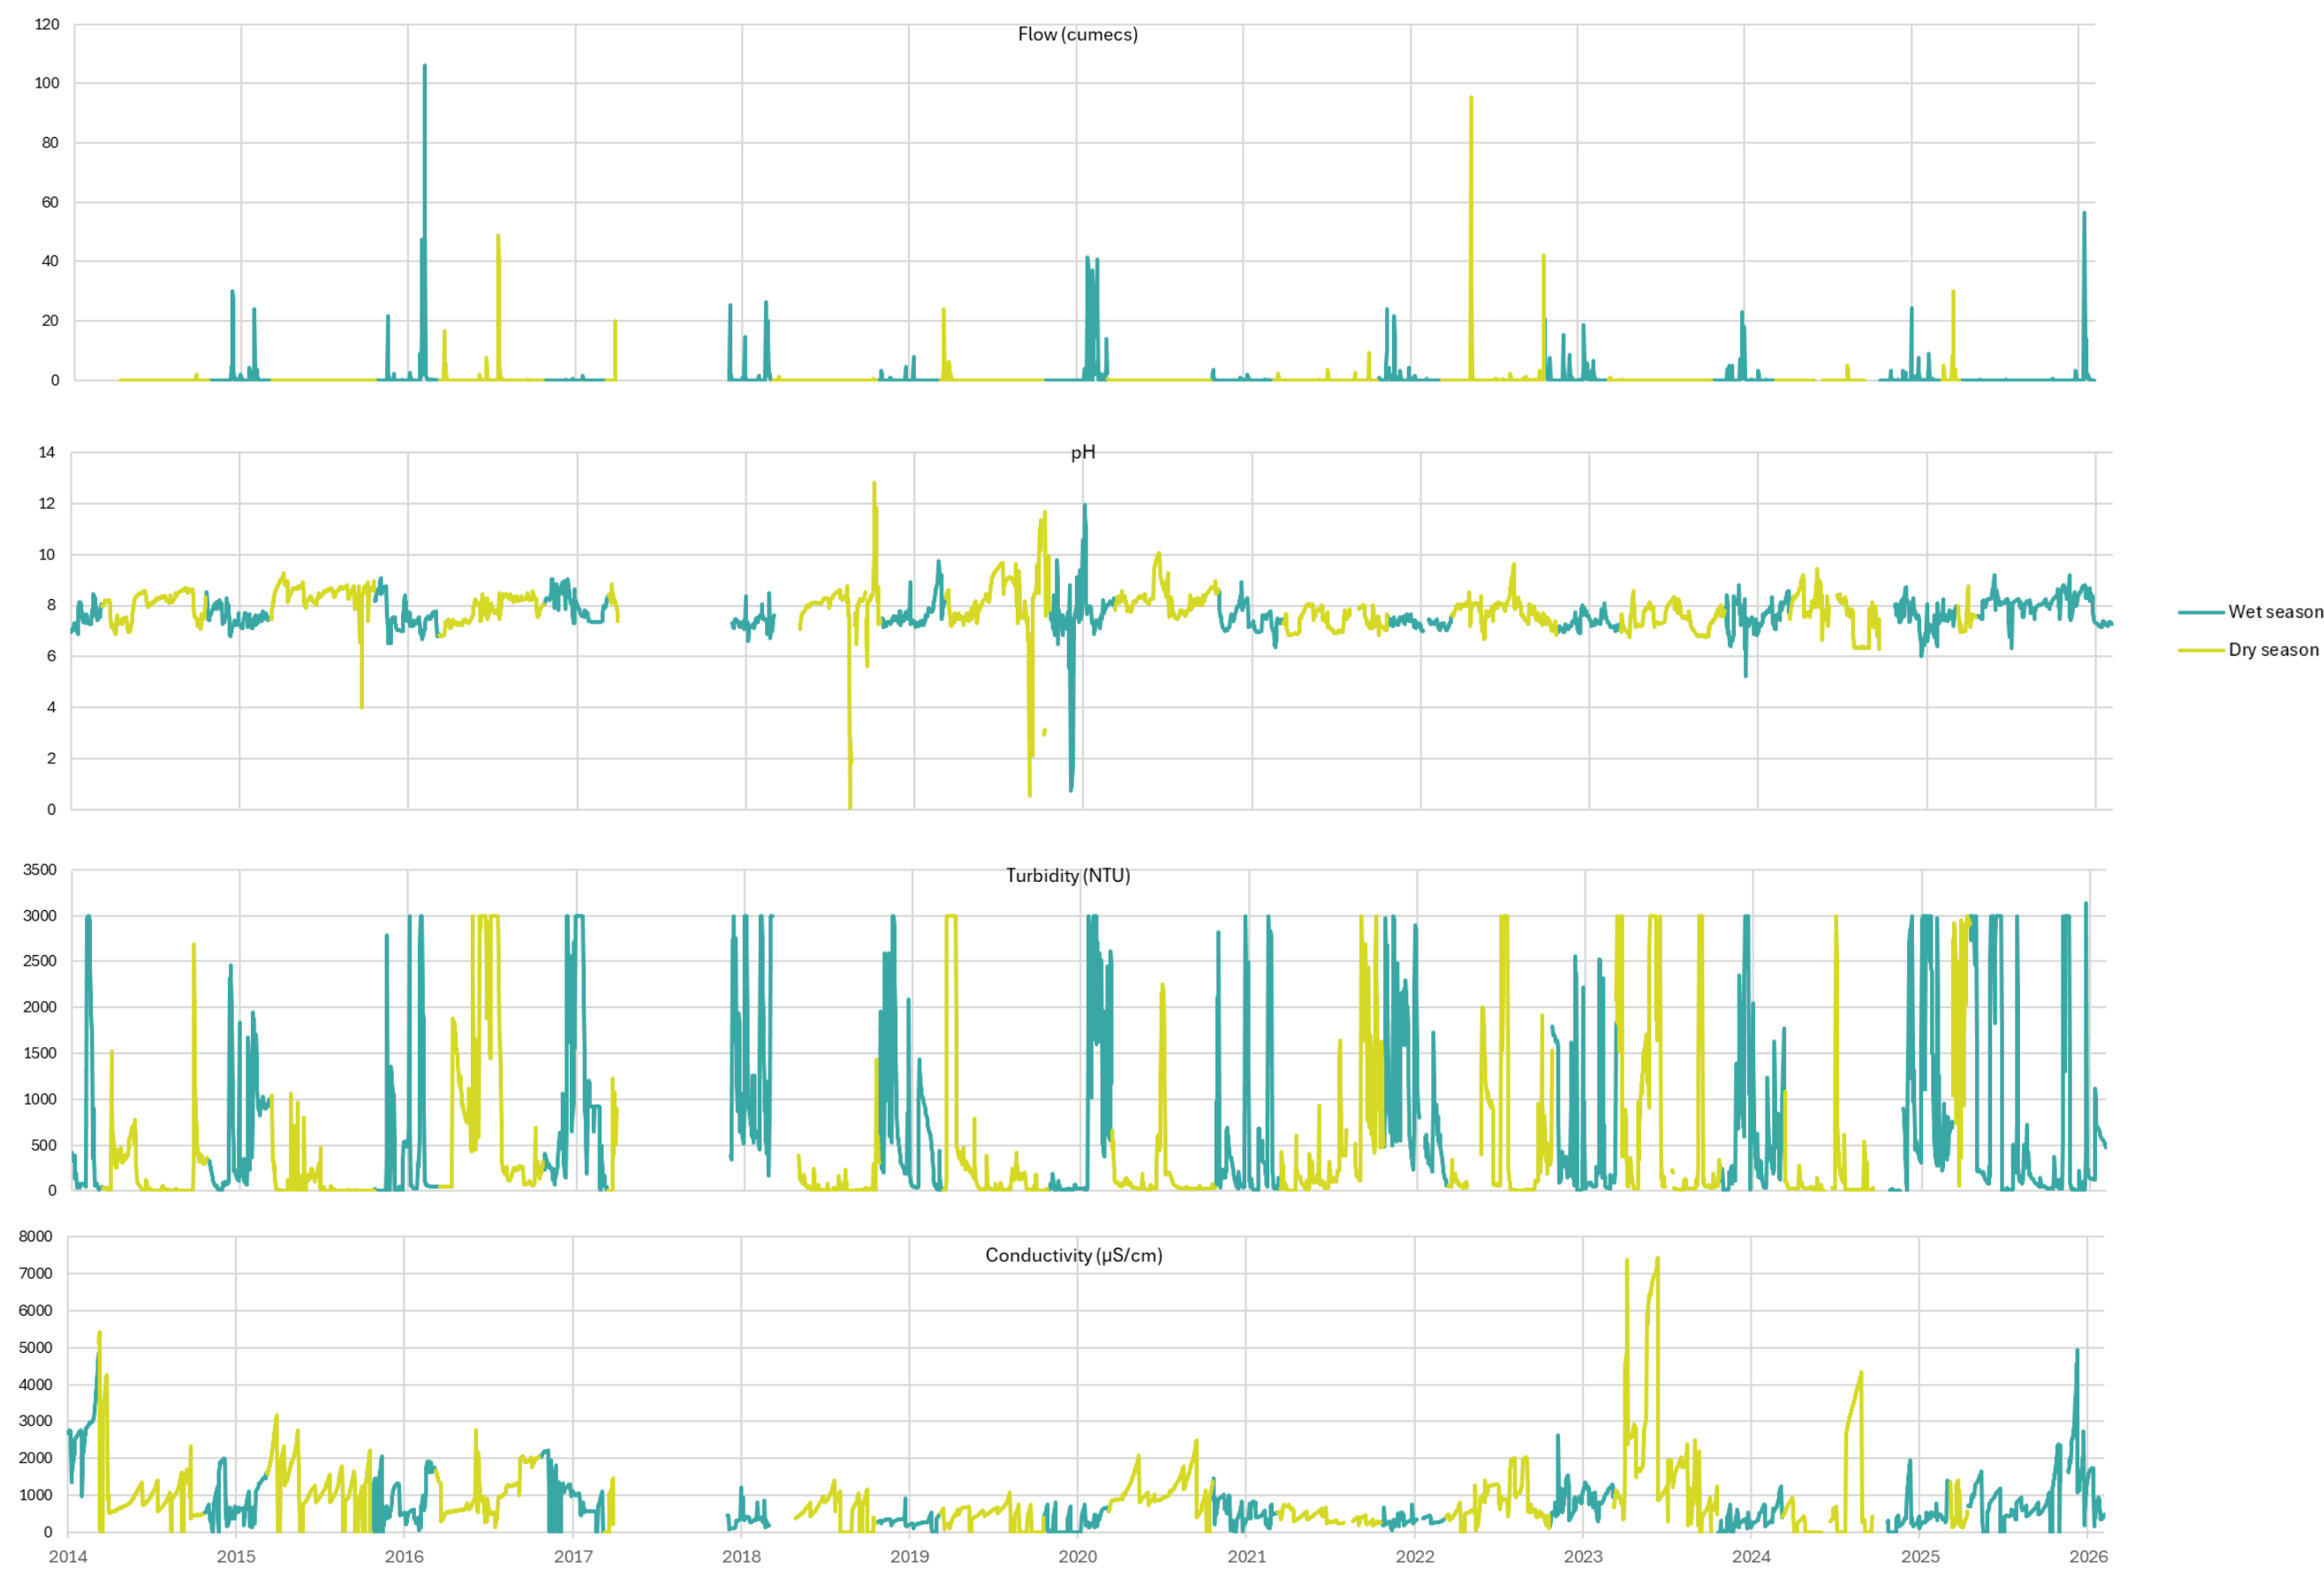
Figure 5-9: Historical continuous data from Blackwater Creek gauging station (331420)

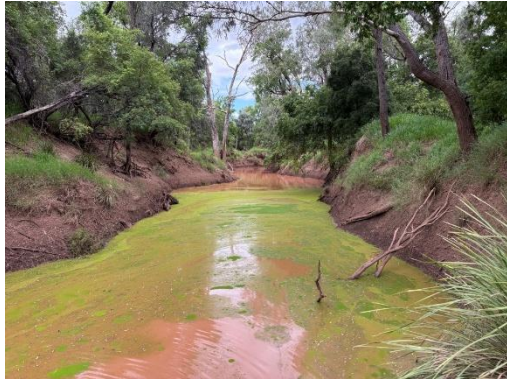
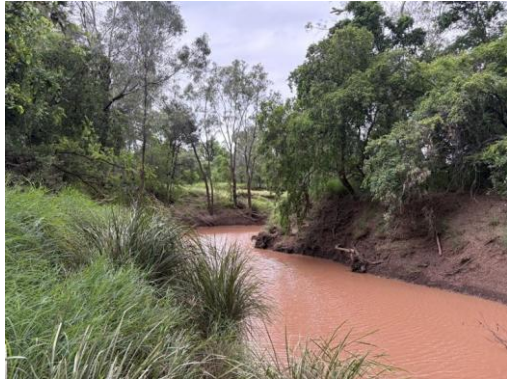
| Upstream | | Downstream | | |

| Water flow: | Slow flowing | Water oils: | None | |
| Pool dimensions (m): | Continuous, 10 | Plume: | Extensive | |

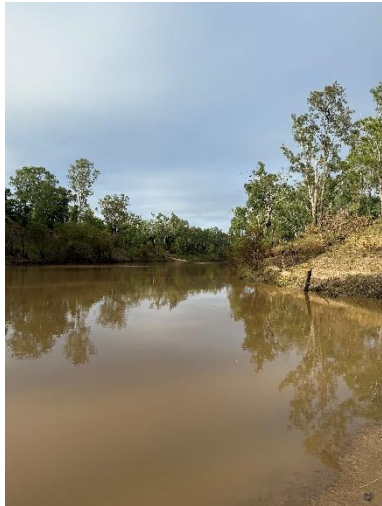
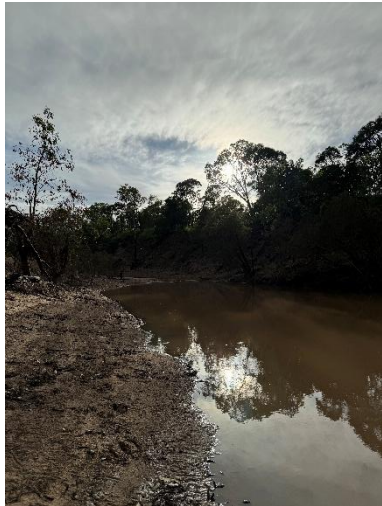
| Upstream | | Downstream | | |

| Water flow: | Slow flowing | Water oils: | None | |
| Pool dimensions (m): | continuous, 20-10 | Plume: | None | |

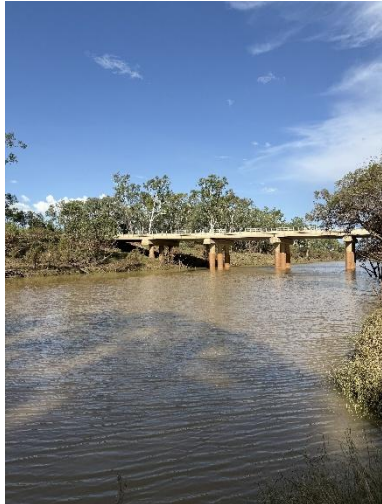
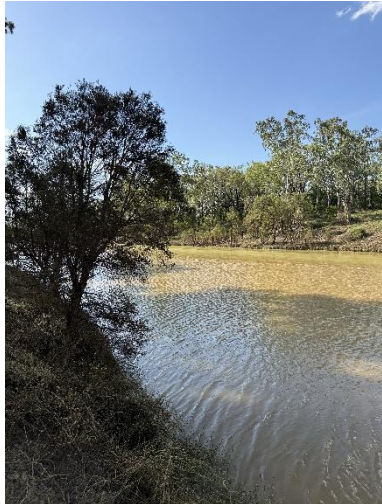
| Upstream | | Downstream | | |

| Water flow: | Slow flowing | Water oils: | None | |
| Pool dimensions (m): | continuous, 40 | Plume: | Little | |

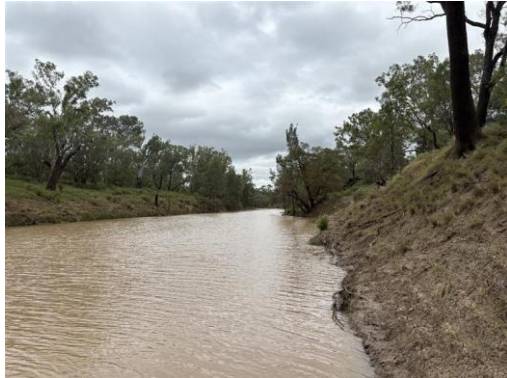
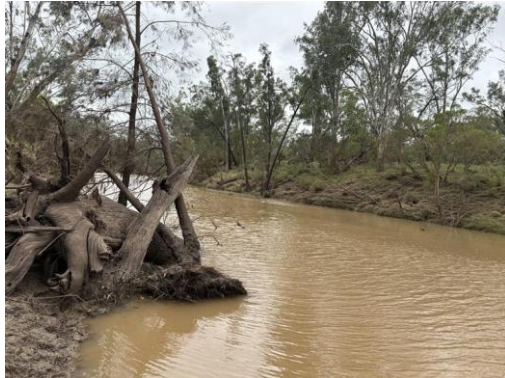
| Water flow: | Slow flowing | Water oils: | None | |
| Pool dimensions (m): | Continuous, 30 | Plume: | Moderate | |

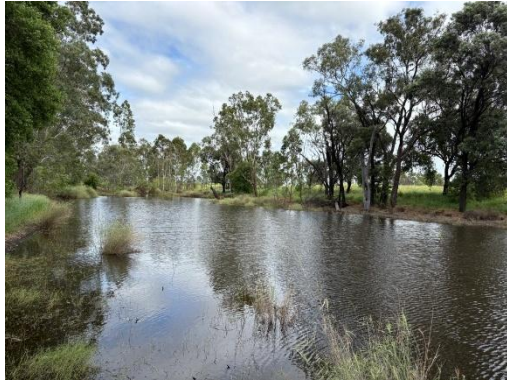
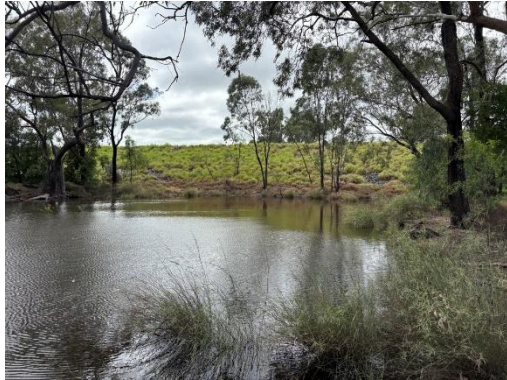
| Upstream | | Downstream | | |

| Water flow: | Standing | Water oils: | None | |
| Pool dimensions (m): | 200, 20 | Plume: | Moderate | |

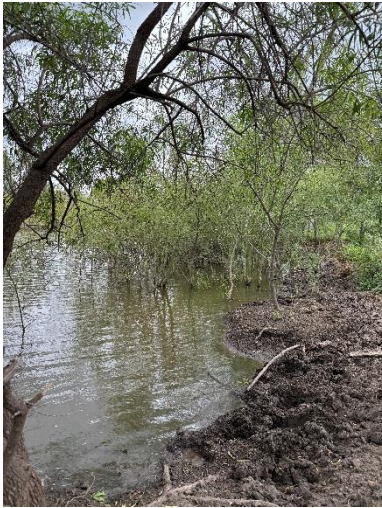
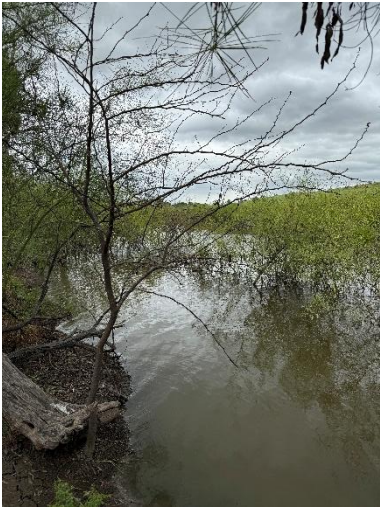
| Upstream | | Downstream | | |

| Water flow: | Standing | Water oils: | None | |
| Pool dimensions (m): | 100+m, continuous, 20 | Plume: | Some | |

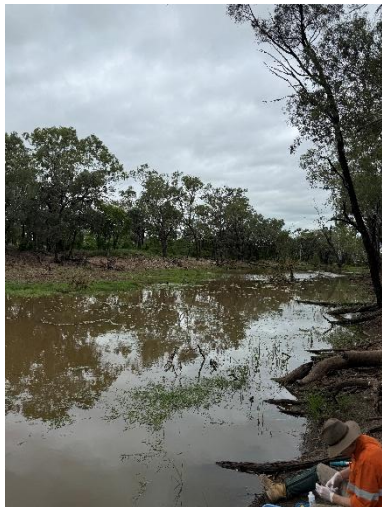
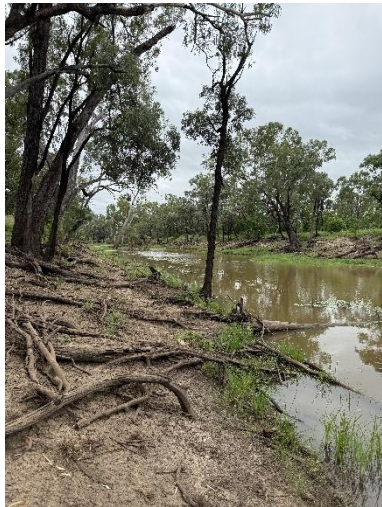
| Upstream | | Downstream | | |

| Water flow: | Slow flowing | Water oils: | None | |
| Pool dimensions (m): | continuous, 20 | Plume: | Little | |

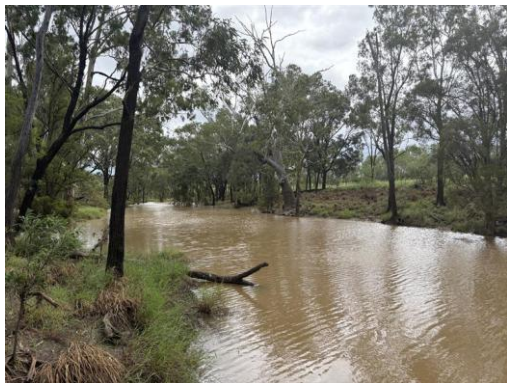
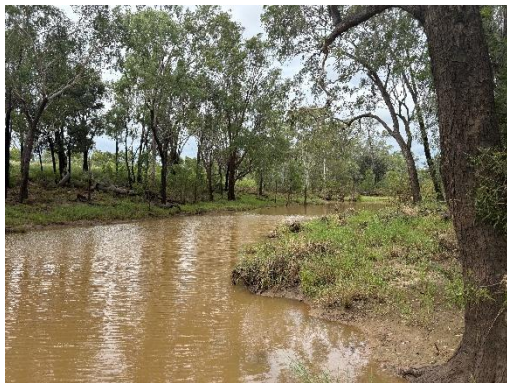
| Water flow: | Standing | Water oils: | None | |
| Pool dimensions (m): | 300, 15 | Plume: | Moderate | |
| Water surface: | Clear, wind has caused a lot of disturbance on the surface, preventing easy detection of oils or algae etc | Sediment smothering: | Yes | |
