# JELLINBAH COAL MINE RECEIVING ENVIRONMENT MONITORING PROGRAM

## 2024 PROGRESS REPORT

PREPARED FOR  
JELLINBAH MINING PTY LTD

19 July 2024

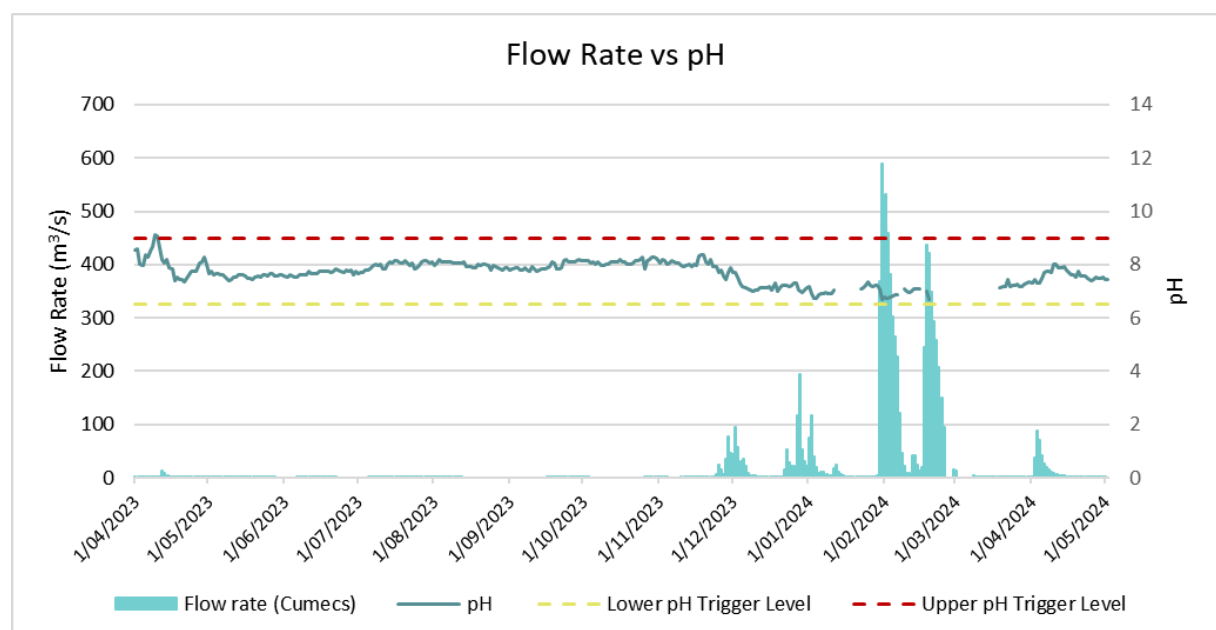
Rises in turbidity appear to correlate with high flow rates, with peaks in December of 2023, as well as January and February of 2024 when flow rate was high. A lack of data in March 2024 means that turbidity levels are unknown during the high flow rate for that month. The high flow trigger level was not exceeded for the monitoring period.

Figure 5-2: Flow rate versus pH at Mackenzie River receiving site gauging station (331423)

Though low pH and EC, and high turbidity was recorded at the sites during the release event in January to February 2024, these levels were similar to background conditions and/or previous high flow conditions and therefore are not considered to be a result of the release event.

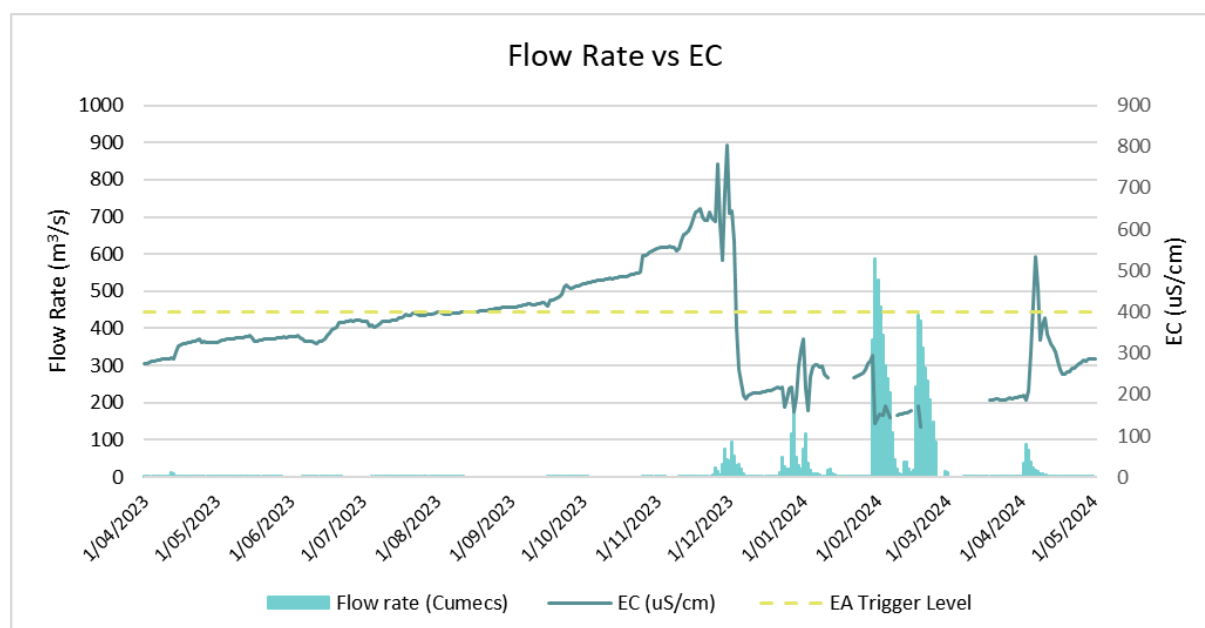
Figure 5-3: Flow rate versus EC at Mackenzie River receiving site gauging station (331423)

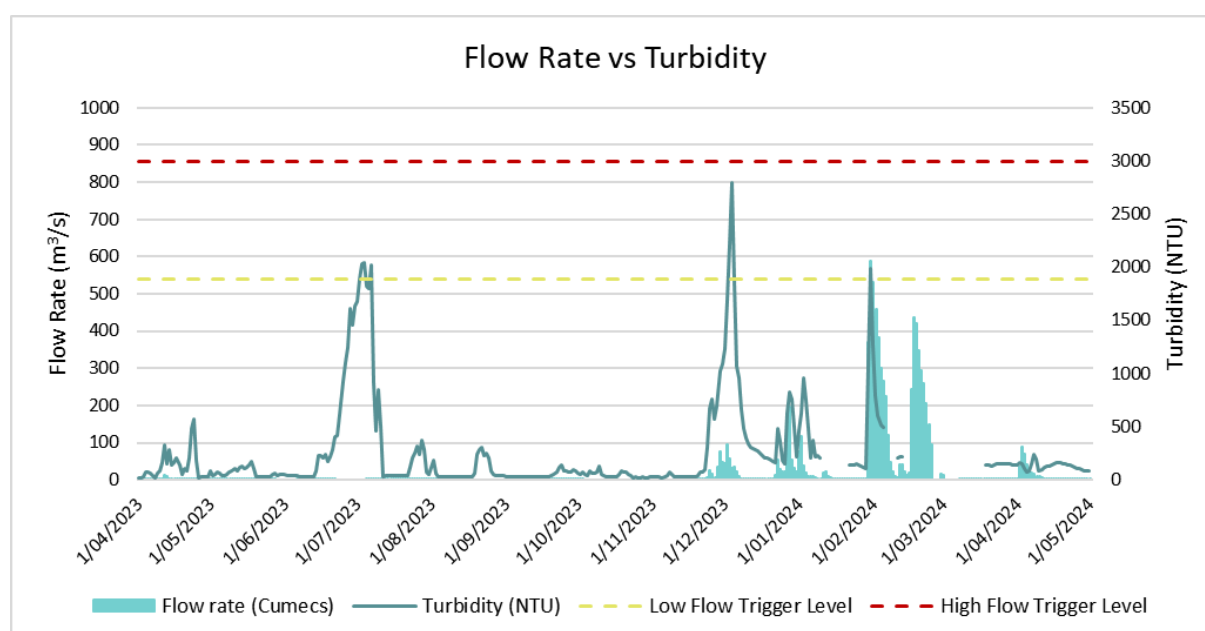
Figure 5-4: Flow rate versus turbidity at Mackenzie River receiving site gauging station (331423)

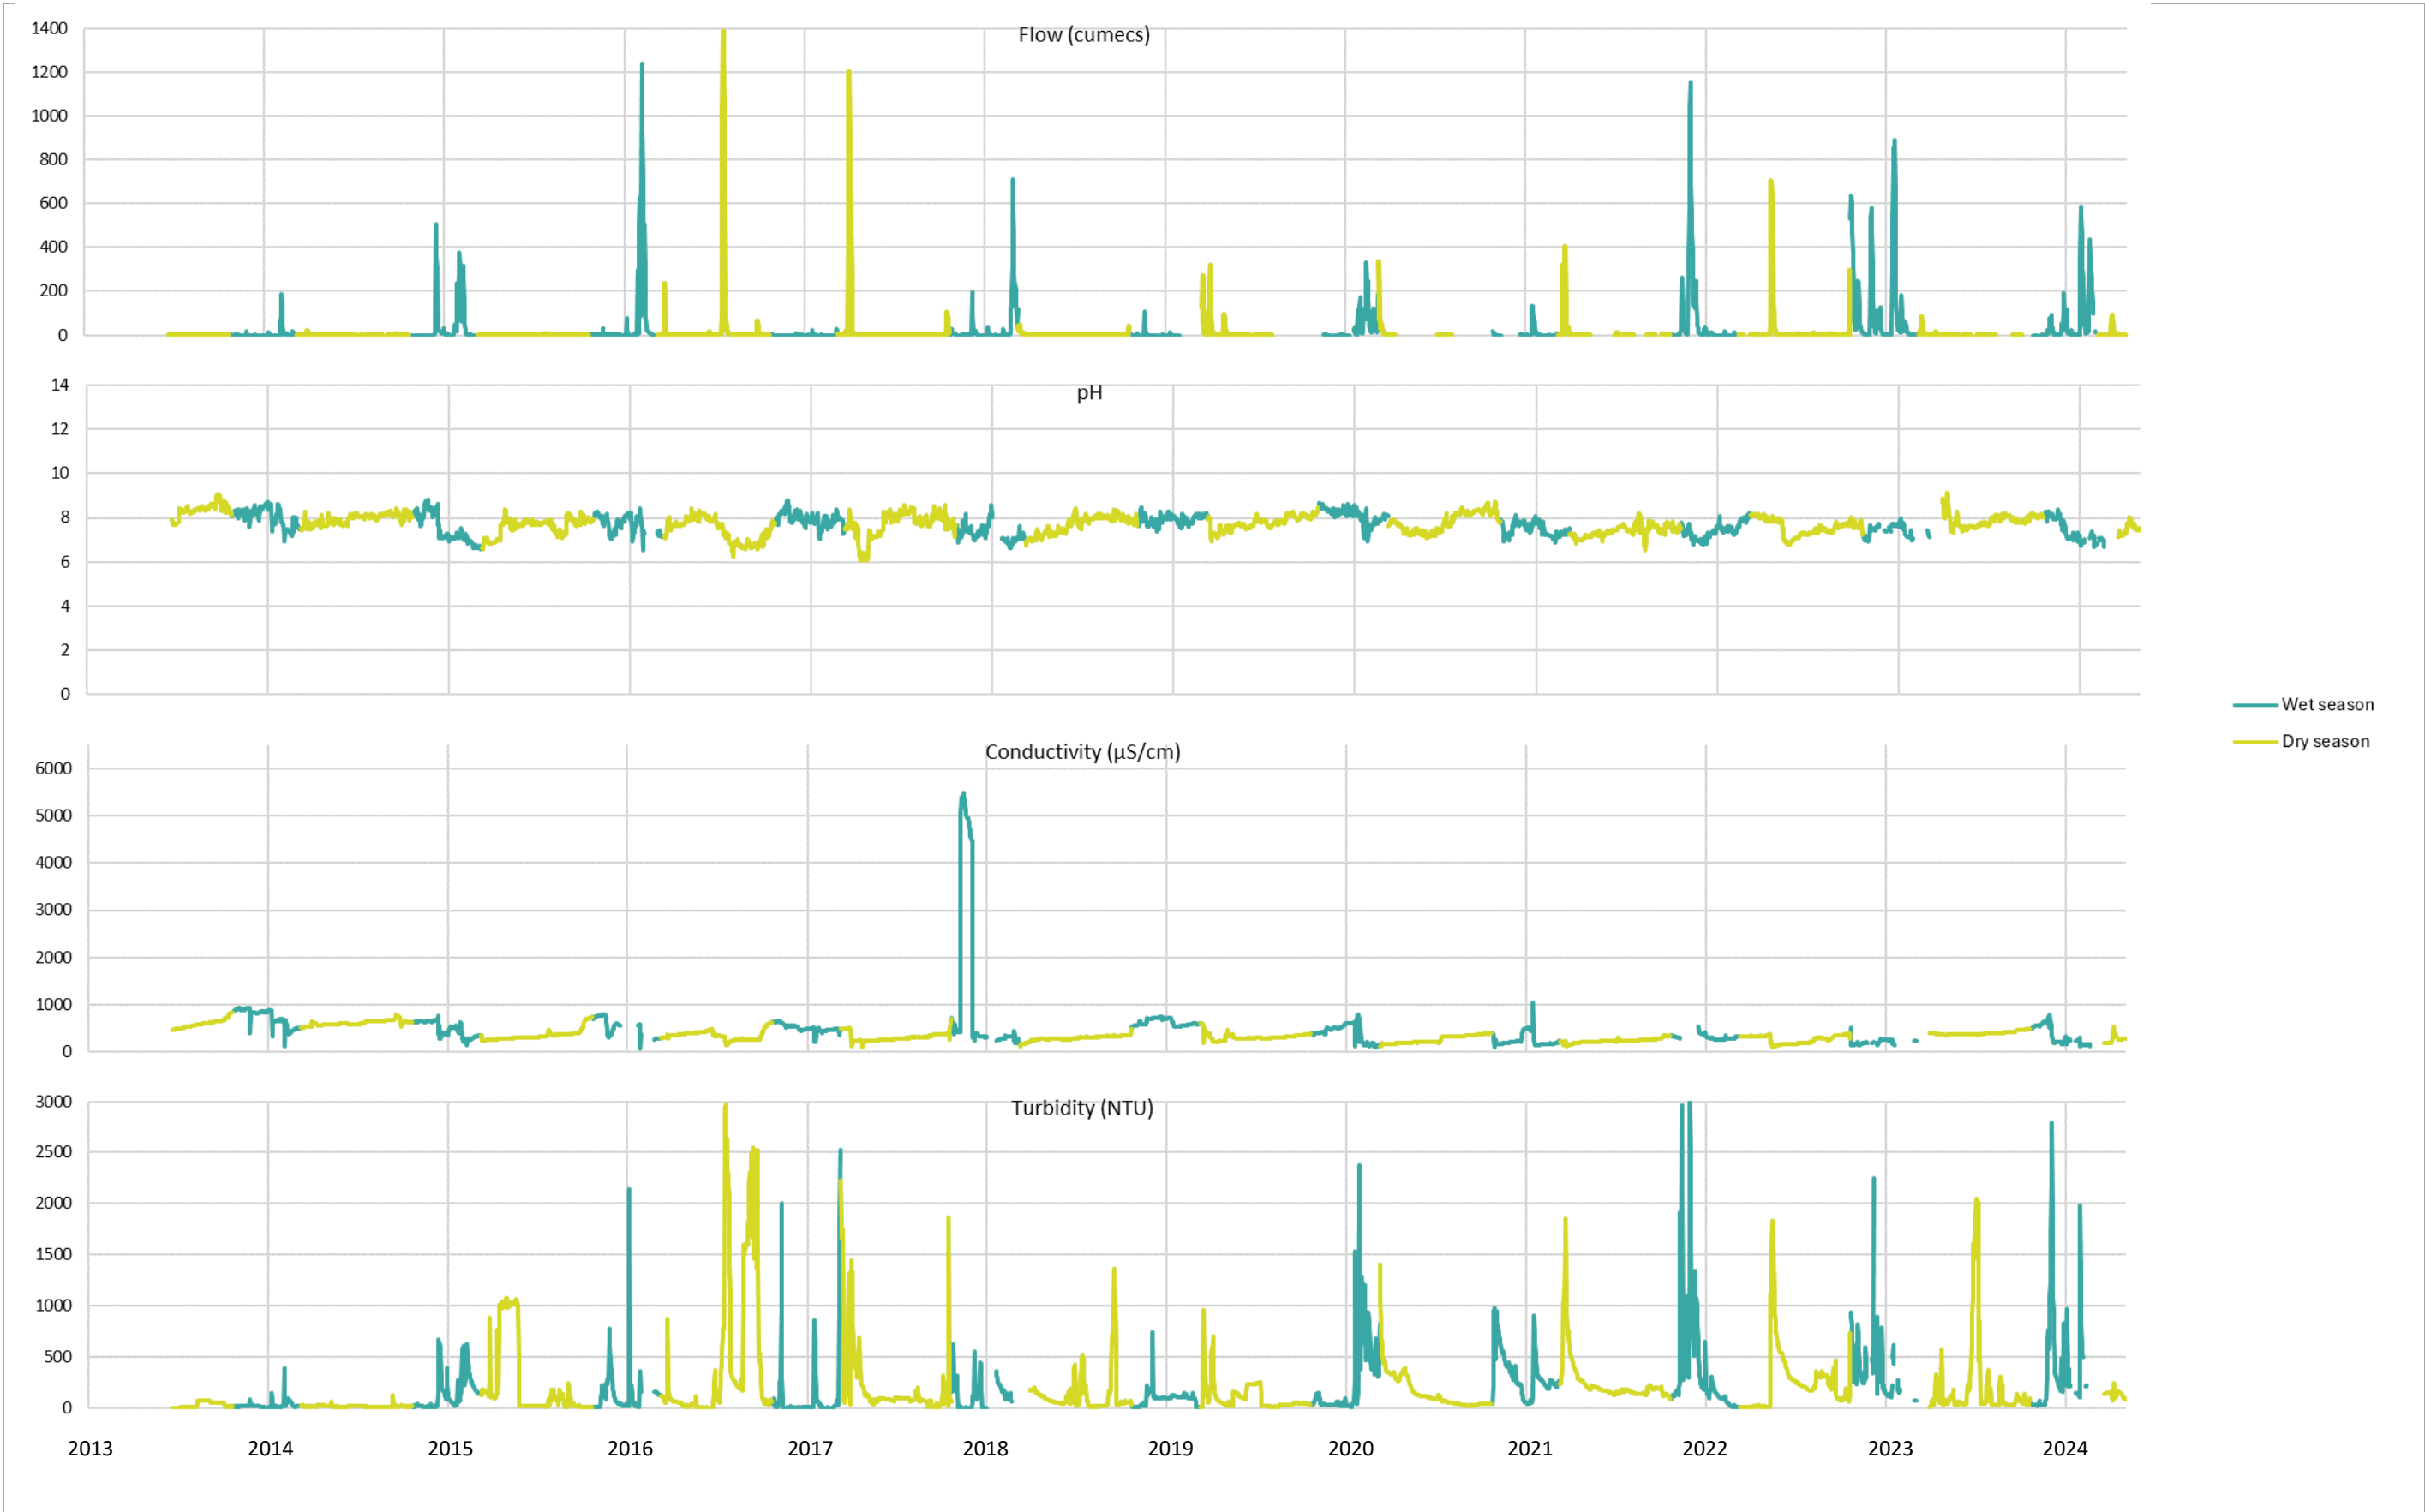
Figure 5-5: Historical continuous data from Mackenzie River gauging station (331423)

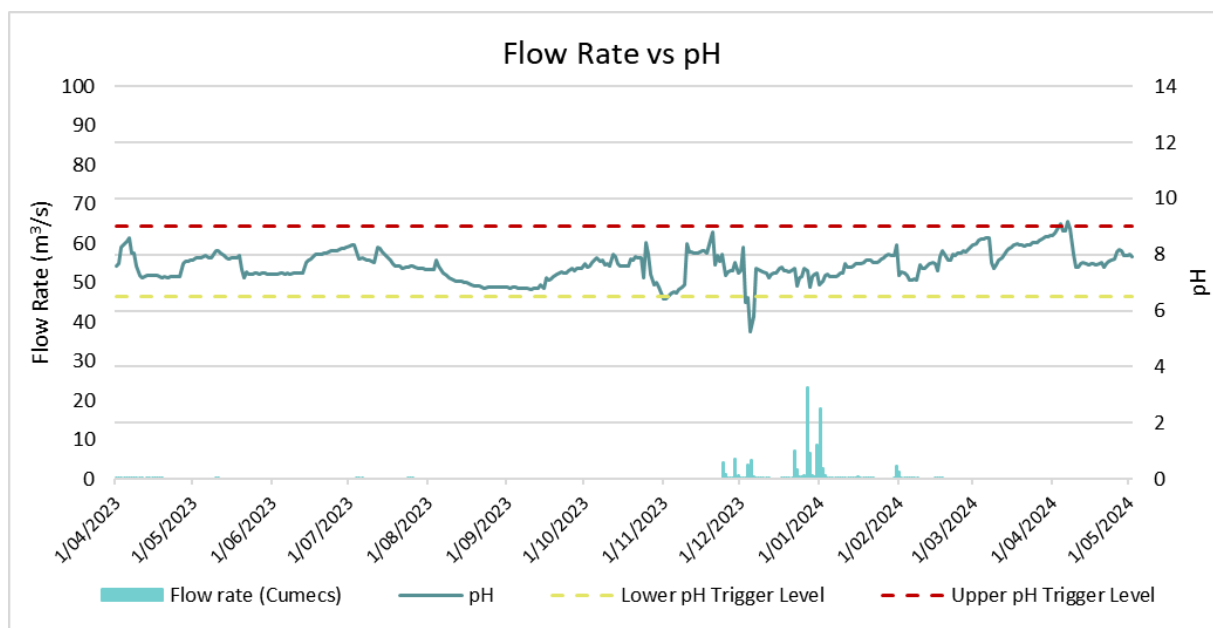
Figure 5-6: Flow rate versus pH at Blackwater Creek gauging station (331420)

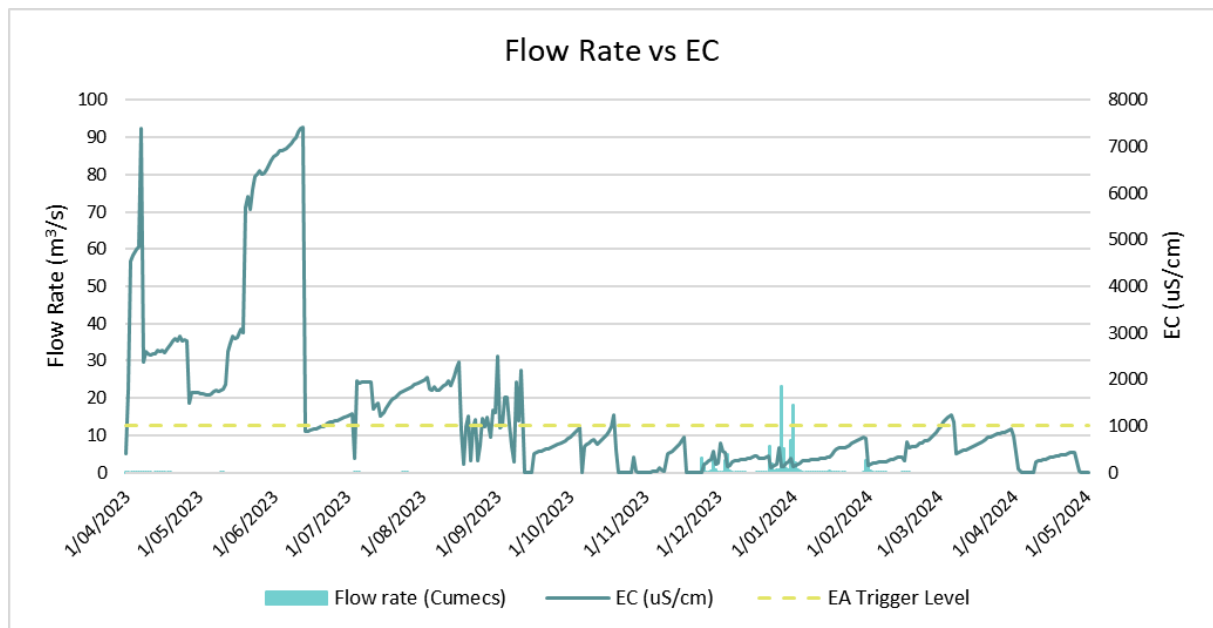
Electrical conductivity was highly variable throughout the year, with peaks in April and June 2023 that were well above the EA trigger level. No correlation appears to be present for flow rate and EC at the Blackwater Creek gauging station.

Figure 5-7: Flow rate versus EC at Blackwater Creek gauging station (331420)

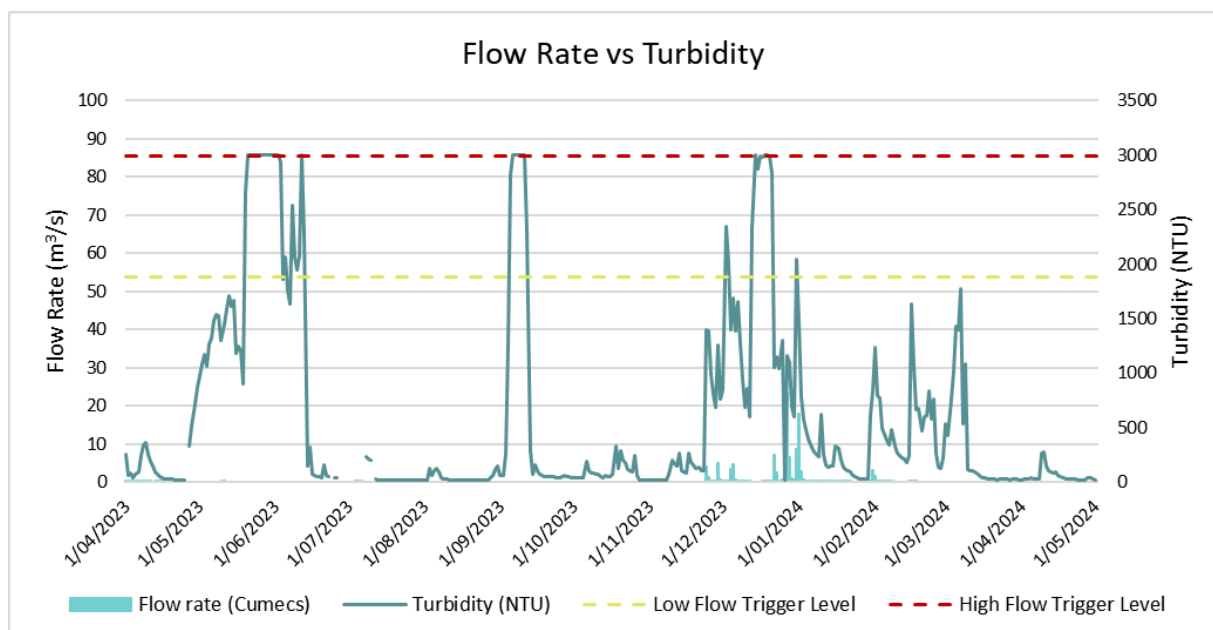
Similarly, turbidity appears to fluctuate throughout the monitoring period, with little to no correlation with flow rate. High turbidity was recorded during high flow rates between December 2023 and February 2024, but these levels did not exceed the high flow trigger level. High turbidity was also recorded in June and September 2023 when flow rate was low, both exceeding the low flow trigger level. Turbidity has historically fluctuated in both wet and dry seasons at the gauging station.

Figure 5-8: Flow rate versus turbidity at Blackwater Creek gauging station (331420)

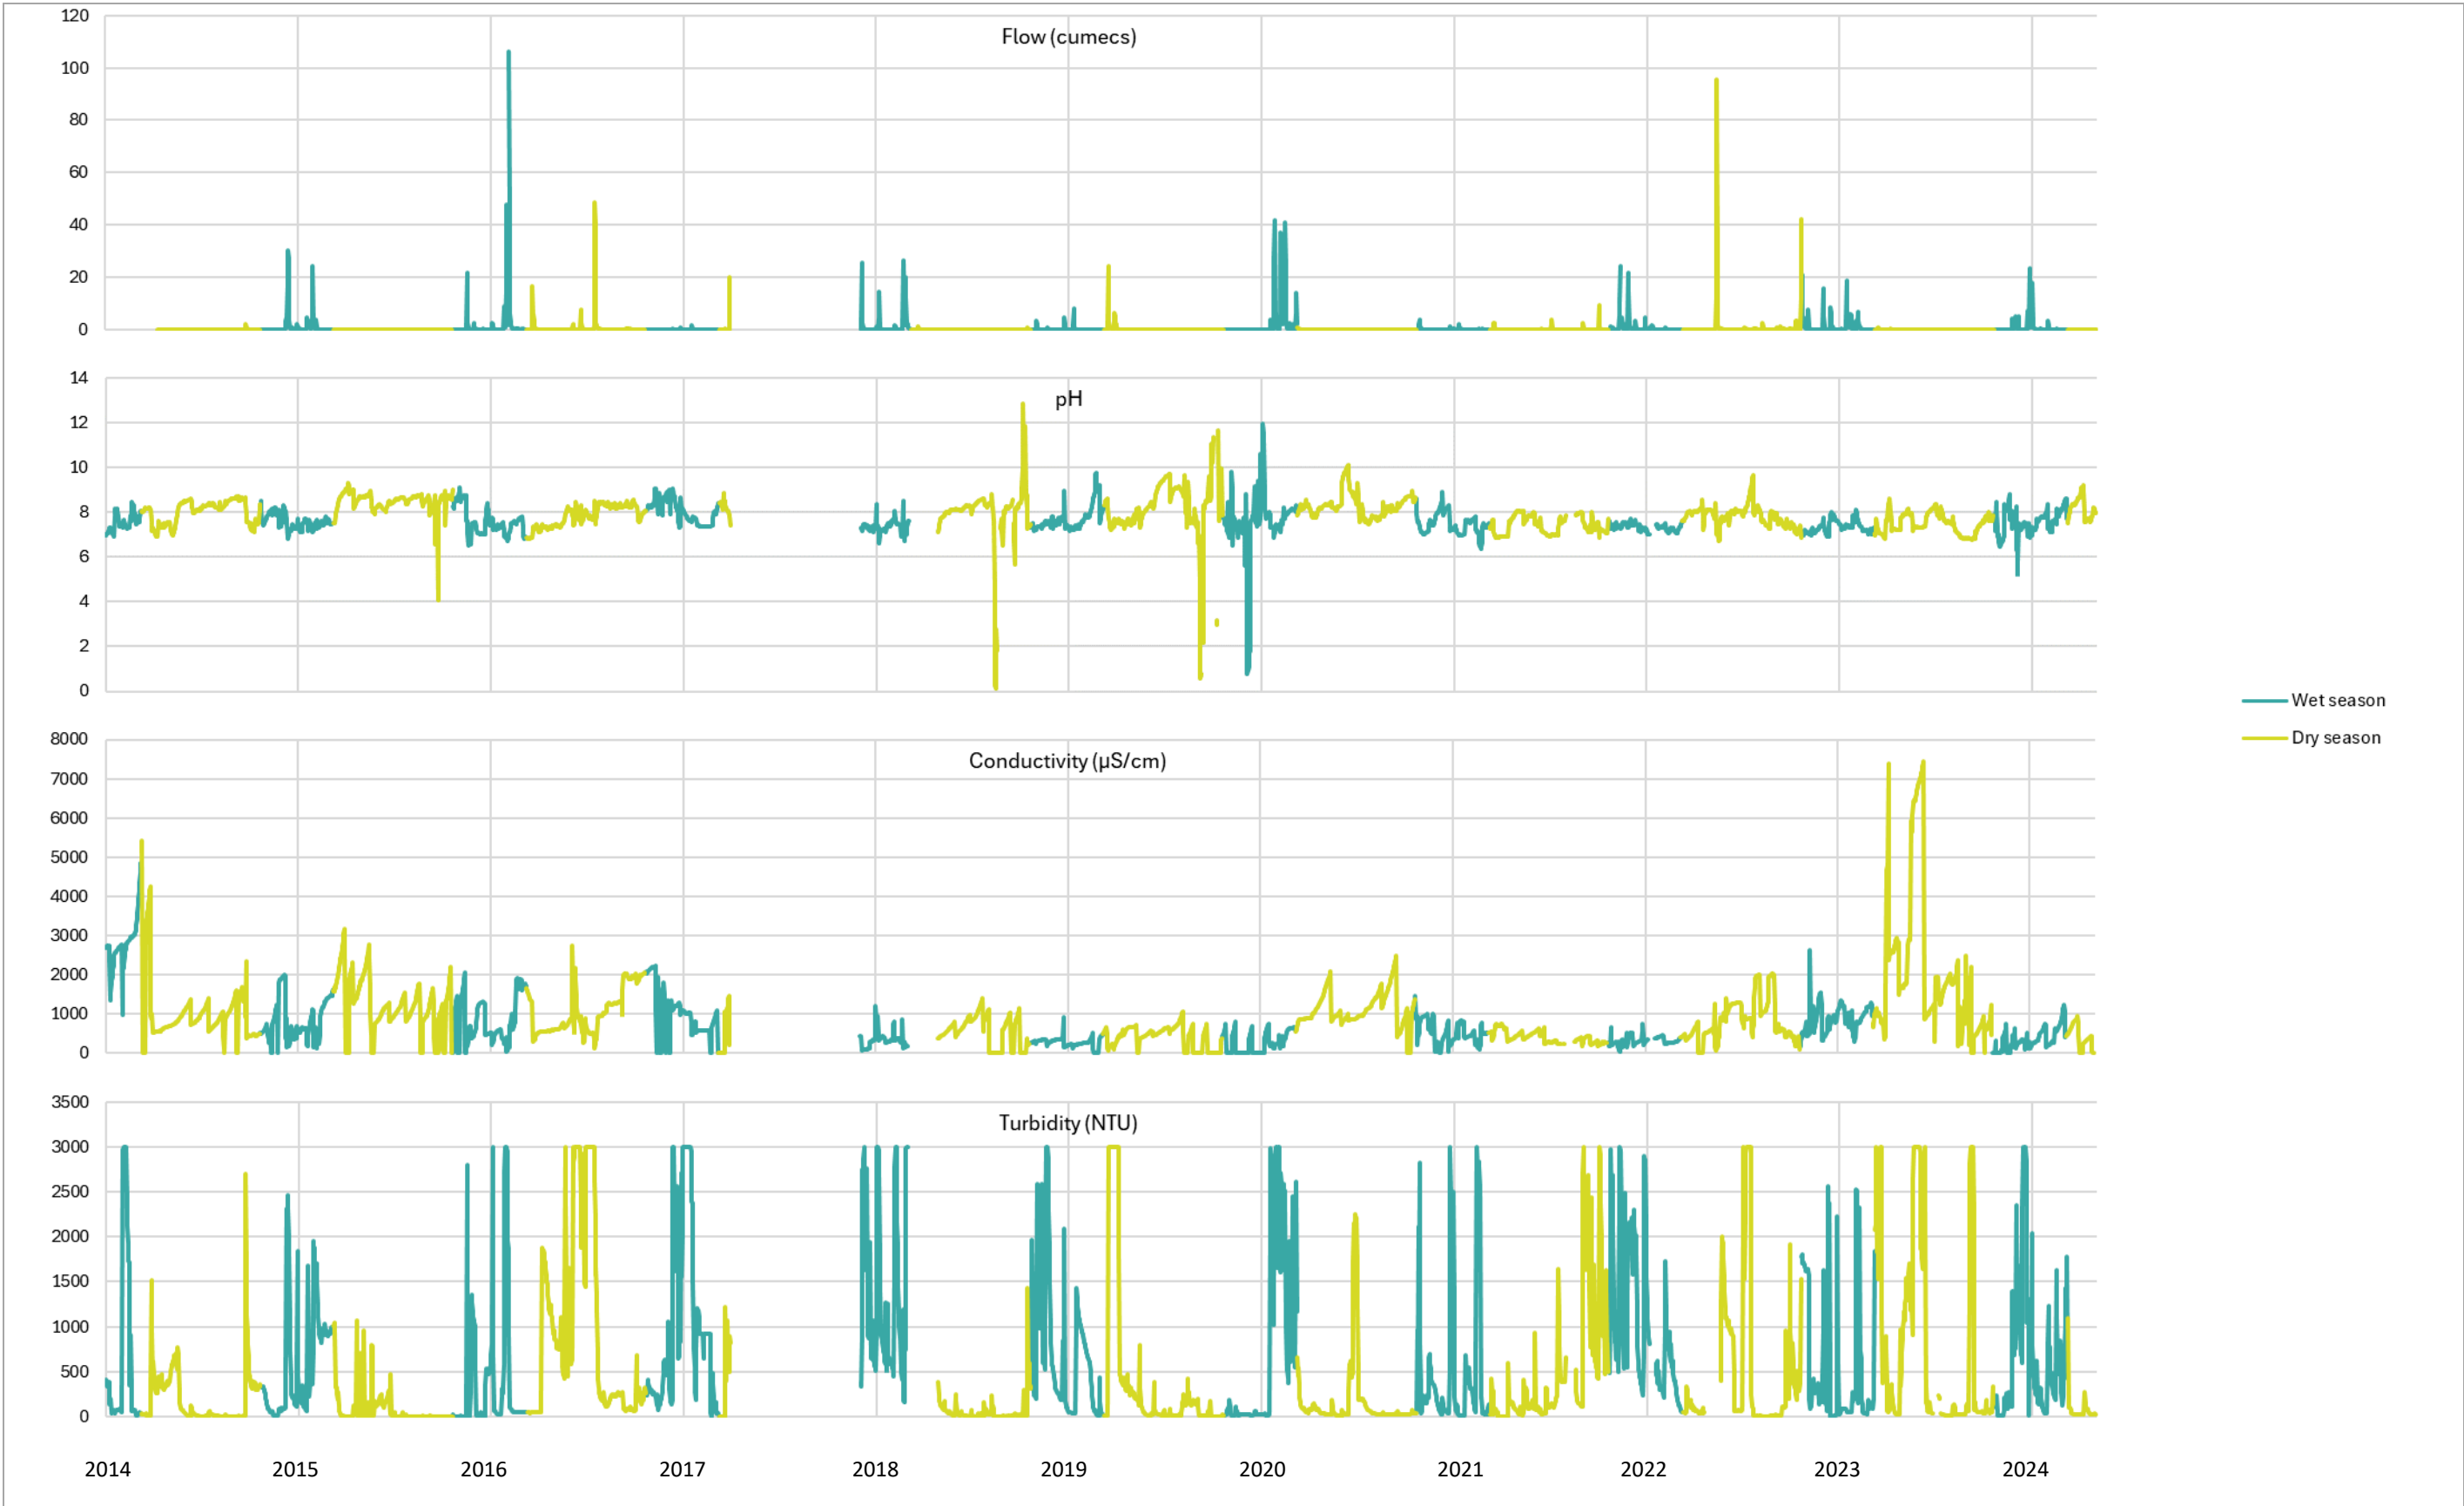
Figure 5-9: Historical continuous data from Blackwater Creek gauging station (331420)

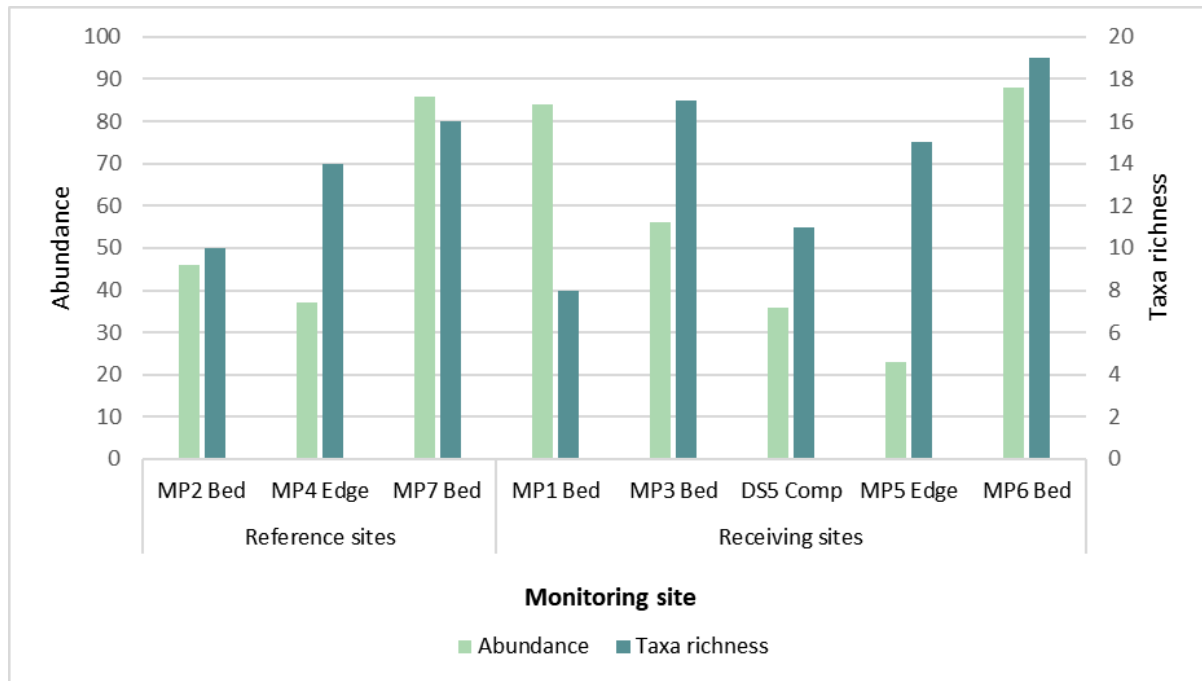
Total abundance and taxa richness for each site are presented in Figure 5-10. Total abundance was higher at the receiving sites when compared with the reference sites at Blackwater Creek and Mackenzie River (for MP3) and was comparable at all other sites. Taxa richness was higher at the receiving site compared with the reference site for the Mackenzie River Anabranh (MP6), but lower at Blackwater Creek (MP1). Taxa richness was comparable at all other sites.

Figure 5-10: Macroinvertebrate total abundance and taxa richness

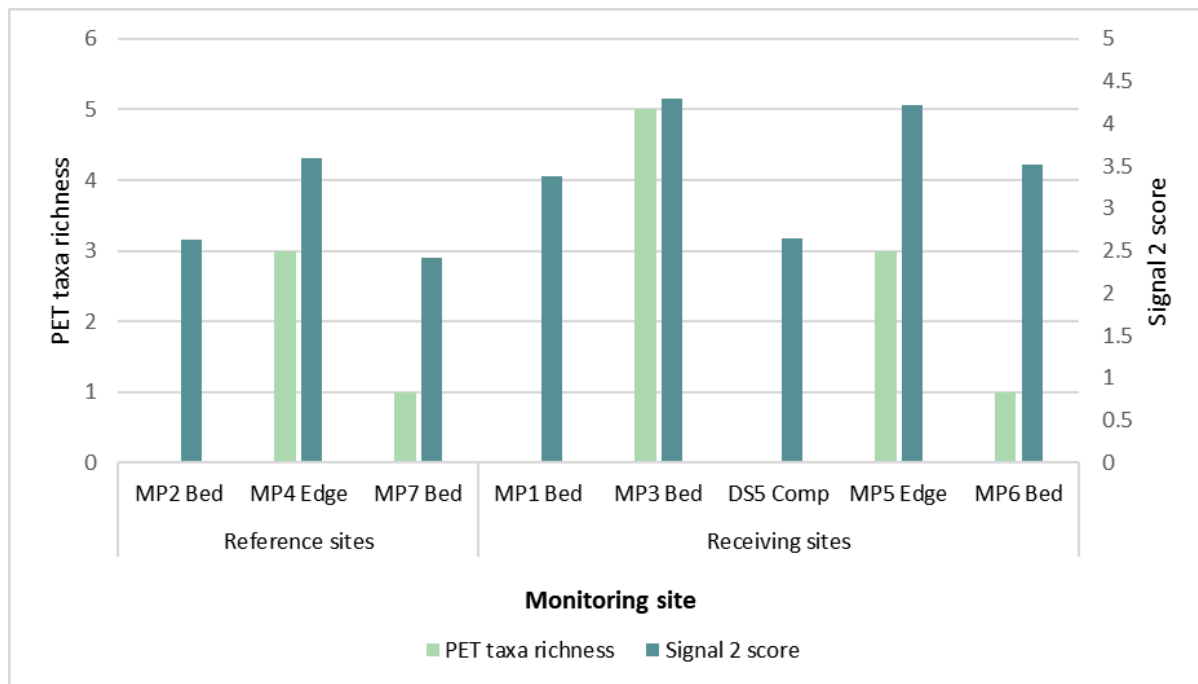
PET richness and Signal 2 scores for each site are presented in Figure 5-11. PET taxa richness was highest in the Mackenzie River sites (MP3, MP4, MP5), as were the Signal 2 scores for these sites. No PET taxa were recorded in either Blackwater Creek sites (MP1 and MP2), and only one PET taxon was recorded at both Mackenzie River Anabranh sites (MP6 and MP7). In general, the receiving sites were comparable with the reference sites for both PET taxa richness and Signal 2 scores.

Figure 5-11: Macroinvertebrate PET taxa richness and Signal 2 index score

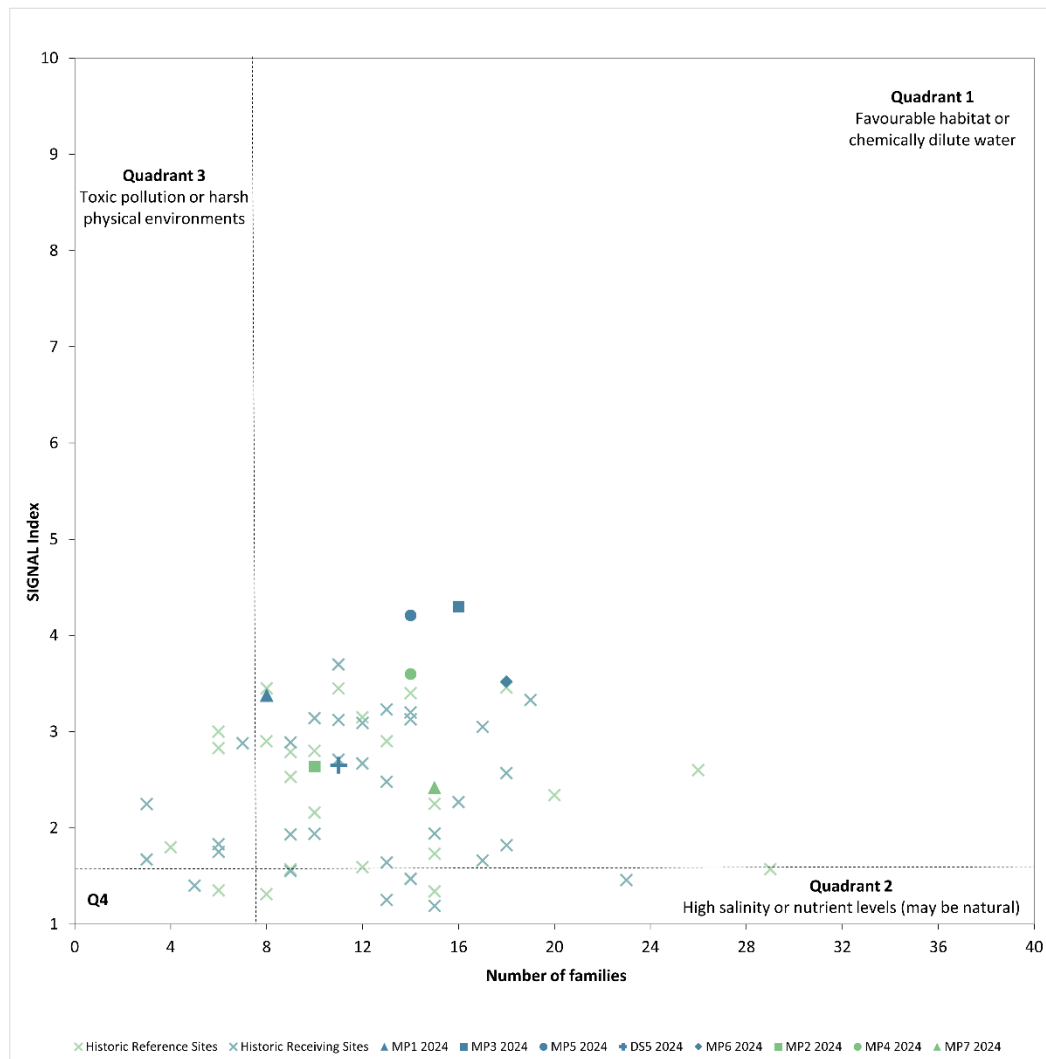
All monitoring sites are placed in quadrant 1, which is representative of favourable habitat or chemically diluted water. Historically, both reference and receiving sites have typically resided within the 1<sup>st</sup> quadrant. Occasionally both receiving and reference sites have results associated with lower water quality (quadrants 2, 3 and 4); however, this is assumed to reflect variable changes in the natural environment.

It is noted that previous years did not set the quadrant boundaries based on the 20<sup>th</sup> percentile for reference site data, however this is not considered to be representative of the study region and local sampling methods. As such, the current data set appears to differ from previous monitoring years, where most data points were within quadrant 4.

Figure 5-12: Signal 2 bi-plot

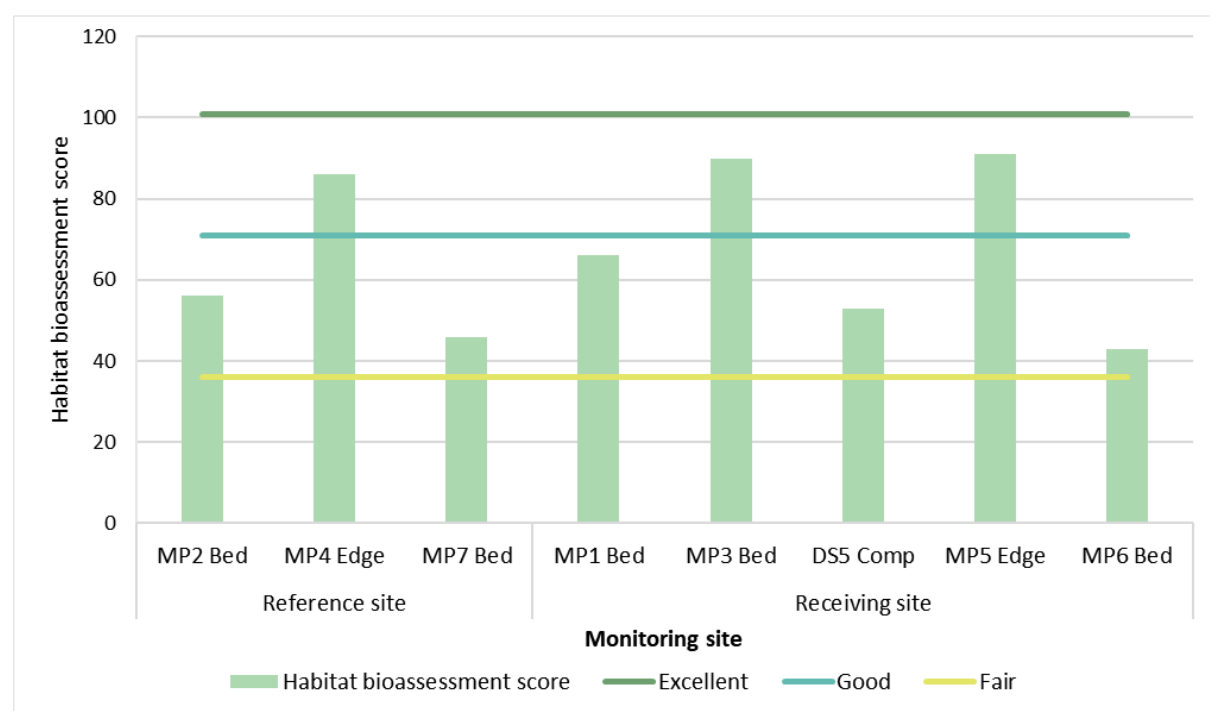
Figure 5-13: Habitat bioassessment scores

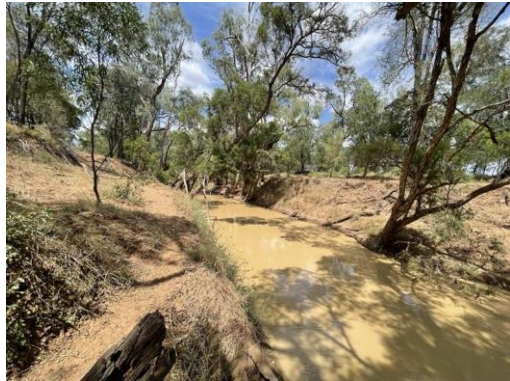
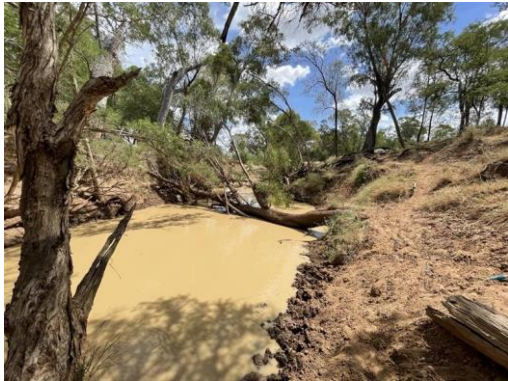
## Monitoring site MP1 (Receiving)

Water flow:	Standing	Water oils:	Absent	
Pool dimensions (m):	35 x 7 m	Plume:	Extensive	
Water surface:	Normal	Sediment smothering:	Absent	
Turbidity:	Turbid	Sediment oils:	Absent	
Water colour:	Opaque	Sediment odour:	Stock	
Bank shape (left/right):	Convex, Stepped	Adjacent land use:	Grazing, landholder track	
Bank slope (left/right):	Steep 60-80°, Moderate 30-60°	Livestock/animal impacts:	Cattle pugging, No pig activity, Other animal evidence	
Erosion observations		Habitat assessment: MP1		
Bare ground:	Moderate 50-75%	Bottom substrate:	Poor	5
Exposed tree roots:	Some 10-50%	Embeddedness:	Good	15
Gully erosion:	Some 10-50%	Velocity/depth category:	Poor	5
Bank slumping:	Little 1-10%	Channel alteration:	Fair	7
Local catchment erosion:	Some 10-50%	Bottom scouring/deposition:	Good	11

Notes:		Pool/riffle, run/bend ratio:	Poor	3
Monitoring site MP1 is a section of Blackwater Creek 1,500 m downstream of RP1. The site is highly disturbed, with lots of bare ground present on both banks. Extensive cattle activity is apparent. The site shows evidence of clearing, though some mature trees remain.		Bank stability:	Fair	5
		Bank vegetation stability:	Fair	5
		Streamside dominant cover:	Excellent	10
		Total score:	Fair	66

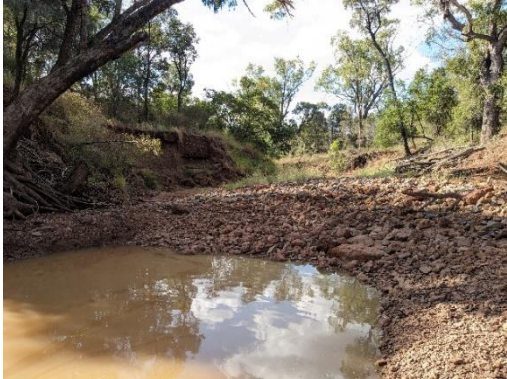
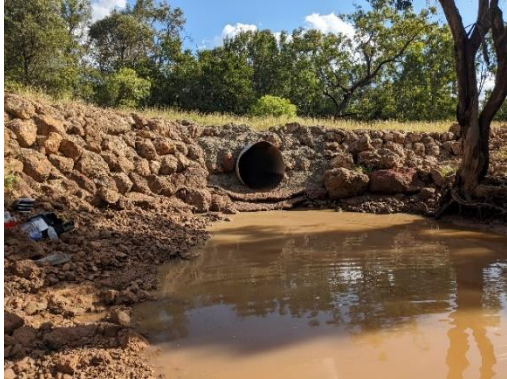
## Monitoring site MP2 (Reference)

Water flow:	Standing	Water oils:	Slight sheen	
Pool dimensions (m):	15 x 8 m	Plume:	Moderate	
Water surface:	Slight slick	Sediment smothering:	Yes	
Turbidity:	Turbid	Sediment oils:	Absent	
Water colour:	Opaque	Sediment odour:	Absent	
Bank shape (left/right):	Concave, Concave	Adjacent land use:	Grazing	
Bank slope (left/right):	Vertical 80-90°, Vertical 80-90°	Livestock/animal impacts:	Cattle pugging, Pig tracks, Kangaroo tracks and bird skeleton found in the dry stream nearby	
Erosion observations		Habitat assessment: MP2		
Bare ground:	Some 10-50%	Bottom substrate:	Good	15
Exposed tree roots:	Extensive >75%	Embeddedness:	Good	15
Gully erosion:	Moderate 50-75%	Velocity/depth category:	Poor	5
Bank slumping:	Some 10-50%	Channel alteration:	Poor	3
Local catchment erosion:	Little 1-10%	Bottom scouring/deposition:	Poor	3

Notes:		Pool/riffle, run/bend ratio:	Poor	3
Small standing pool of Blackwater Creek located next to a crossing and drain pipe. Artificial rock walls present either side of the track crossing for bank stability. Some evidence of sediment smothering present on rocks around the pool.		Bank stability:	Poor	2
		Bank vegetation stability:	Poor	2
		Streamside dominant cover:	Good	8
		Total score:	Fair	56

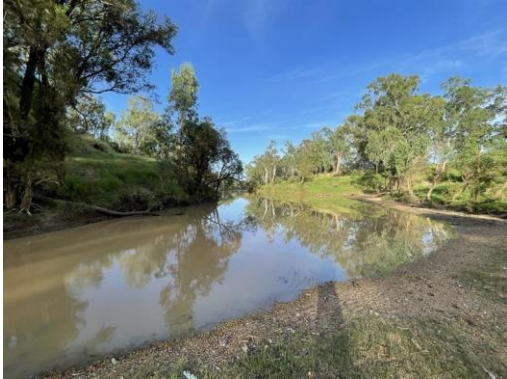
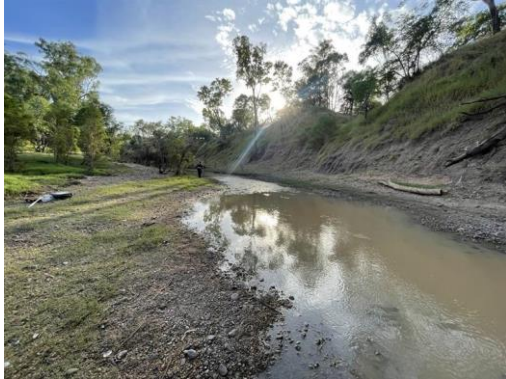
## Monitoring site MP3 (Receiving)

Water flow:	Slow flowing	Water oils:	None	
Pool dimensions (m):	500 m (continuous) x 8 m	Plume:	Moderate	
Water surface:	Normal	Sediment smothering:	Absent	
Turbidity:	Turbid	Sediment oils:	Absent	
Water colour:	Turbid	Sediment odour:	None	
Bank shape (left/right):	Convex, Lower bench	Adjacent land use:	Grazing, access track	
Bank slope (left/right):	Flat <10°, Vertical 80-90°	Livestock/animal impacts:	Cattle pugging, Pig tracks, Dingo (heard), extensive bird diversity, discarded bivalve shells	
Erosion observations		Habitat assessment: MP3		
Bare ground:	Moderate 50-75%	Bottom substrate:	Excellent	20
Exposed tree roots:	Moderate 50-75%	Embeddedness:	Fair	10
Gully erosion:	Moderate 50-75%	Velocity/depth category:	Good	15
Bank slumping:	Little 1-10%	Channel alteration:	Good	11

Local catchment erosion:	Moderate 50-75%	Bottom scouring/deposition:	Good	11
Notes:		Pool/riffle, run/bend ratio:	Good	11
MP3 is a section of the Mackenzie River located at an old crossing point opposite to a water monitoring station. The sample point was located between a deep, slow flowing section of water that flows into a faster flowing riffle section.		Bank stability:	Poor	2
		Bank vegetation stability:	Fair	5
		Streamside dominant cover:	Fair	5
		Total score:	Good	90

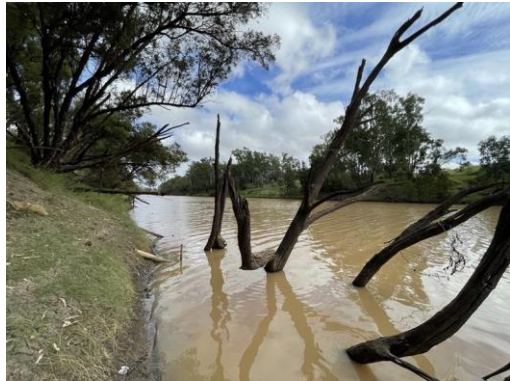
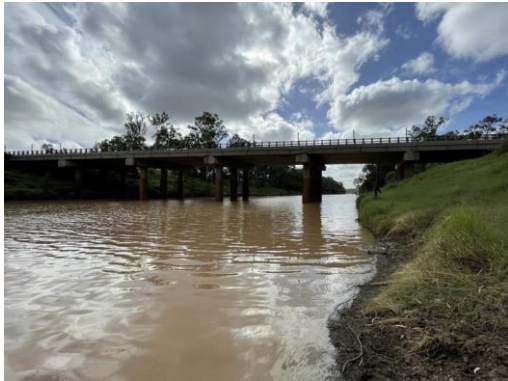
## Monitoring site MP4 (Reference)

Water flow:	Slow flowing	Water oils:	Absent	
Pool dimensions (m):	500m (continuous) x 25 m	Plume:	Some	
Water surface:	Normal	Sediment smothering:	None	
Turbidity:	Turbid	Sediment oils:	Absent	
Water colour:	Turbid	Sediment odour:	Absent	
Bank shape (left/right):	Convex, Convex	Adjacent land use:	Haul road bridge, water monitoring station	
Bank slope (left/right):	Steep 60-80°, Moderate 30-60°	Livestock/animal impacts:	Cattle tracks, Pig tracks, Toad - eaten by a bird	
Erosion observations		Habitat assessment: MP4		
Bare ground:	Little 1-10%	Bottom substrate:	Fair	10
Exposed tree roots:	Little 1-10%	Embeddedness:	Fair	10
Gully erosion:	Little 1-10%	Velocity/depth category:	Fair	10
Bank slumping:	Some 10-50%	Channel alteration:	Good	11
Local catchment erosion:	Little 1-10%	Bottom scouring/deposition:	Good	11

Notes:		Pool/riffle, run/bend ratio:	Good	11
Upstream Mackenzie River section located next to water monitoring point and haul road river crossing. Banks were highly cleared and covered with grass. Sample point was located near fallen trees in the water.		Bank stability:	Fair	5
		Bank vegetation stability:	Excellent	10
		Streamside dominant cover:	Good	8
		Total score:	Good	86

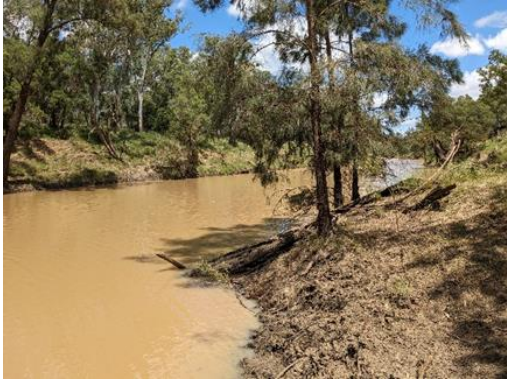
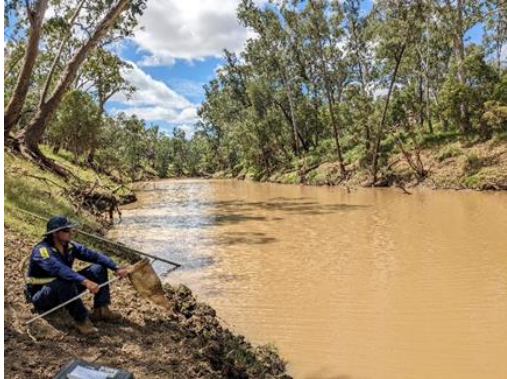
## Monitoring site MP5 (Receiving)

Water flow:	Slow flowing	Water oils:	Absent	
Pool dimensions (m):	500m continuous, 22	Plume:	Some	
Water surface:	Normal	Sediment smothering:	Absent	
Turbidity:	Turbid	Sediment oils:	Absent	
Water colour:	Opaque	Sediment odour:	Absent	
Bank shape (left/right):	Concave, Concave	Adjacent land use:	grazing	
Bank slope (left/right):	Steep 60-80°, Steep 60-80°	Livestock/animal impacts:	Cattle pugging, possible pig tracks, Toad - eaten by a bird	
Erosion observations		Habitat assessment: MP5		
Bare ground:	Little 1-10%	Bottom substrate:	Fair	10
Exposed tree roots:	Little 1-10%	Embeddedness:	Good	15
Gully erosion:	Little 1-10%	Velocity/depth category:	Fair	10
Bank slumping:	Little 1-10%	Channel alteration:	Good	11
Local catchment erosion:	Some 10-50%	Bottom scouring/deposition:	Good	11

Notes:		Pool/riffle, run/bend ratio:	Good	11
Mackenzie River section located near a water monitoring pipe. Slopes were steep and bare with visible evidence of cattle pugging. Vegetation clearing was evident though some mature trees remain.		Bank stability:	Fair	5
		Bank vegetation stability:	Good	8
		Streamside dominant cover:	Excellent	10
		Total score:	Good	91

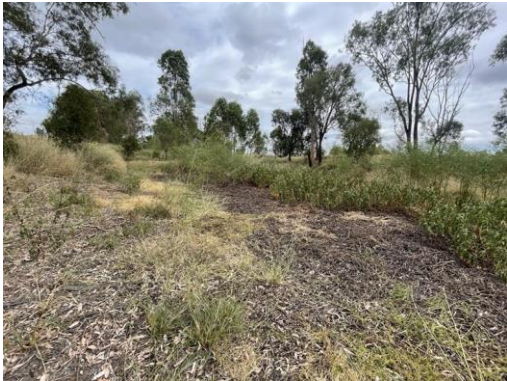
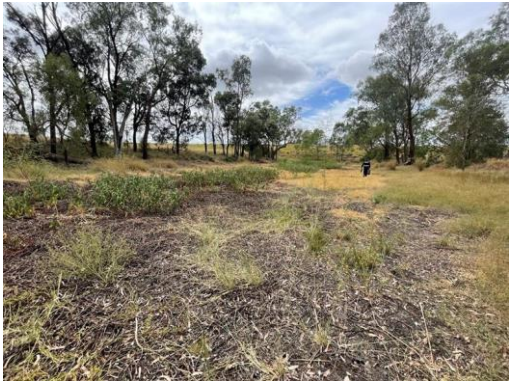
## Monitoring site US3 (Reference)

Water flow:	Dry	Water oils:	-	
Pool dimensions (m):	N/A	Plume:	-	
Water surface:	-	Sediment smothering:	Absent	
Turbidity:	-	Sediment oils:	Absent	
Water colour:	-	Sediment odour:	Absent	
Bank shape (left/right):	Wide, Wide	Adjacent land use:	Grazing	
Bank slope (left/right):	Flat <10°, Flat <10°	Livestock/animal impacts:	Cattle spotted nearby, pugging, pig wallow, pig spotted at site, birds present	
Erosion observations		Habitat assessment: US3		
Bare ground:	Little 1-10%	Bottom substrate:	-	N/A
Exposed tree roots:	None 0%	Embeddedness:	-	N/A
Gully erosion:	Little 1-10%	Velocity/depth category:	-	N/A
Bank slumping:	None 0%	Channel alteration:	-	N/A
Local catchment erosion:	Some 10-50%	Bottom scouring/deposition:	-	N/A
Notes:		Pool/riffle, run/bend ratio:	-	N/A
Dry creek bed at the edge of ML and landholder property, upstream of a culvert track crossing. Large pig wallow was present at monitoring point, and one pig was spotted at the site. Creek bed was overgrown with weeds. No water sample was taken at the site; however sediment was collected.		Bank stability:	-	N/A

Bank vegetation stability:	-	N/A
		Streamside dominant cover:	-	N/A
		Total score:	N/A	N/A

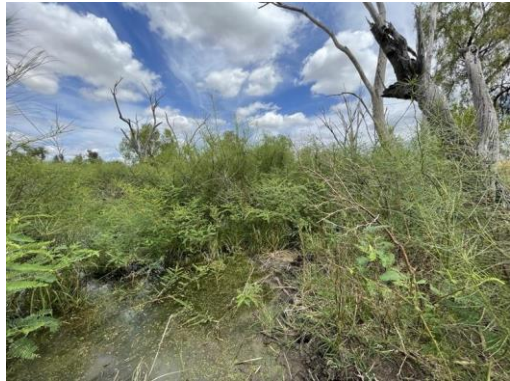
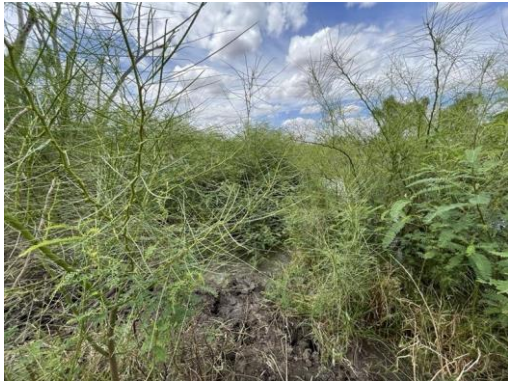
## Monitoring site DS5 (Receiving)

Water flow:	Standing	Water oils:	None	
Pool dimensions (m):	500m x 15 m	Plume:	Some	
Water surface:	Normal	Sediment smothering:	Absent	
Turbidity:	Slight	Sediment oils:	Absent	
Water colour:	Slight	Sediment odour:	None	
Bank shape (left/right):	Wide, Wide	Adjacent land use:	Grazing, landholder track	
Bank slope (left/right):	Flat <10°, Flat <10°	Livestock/animal impacts:	Cattle tracks, extensive cattle pugging, pig tracks	
Erosion observations		Habitat assessment: DS5		
Bare ground:	Some 10-50%	Bottom substrate:	Poor	5
Exposed tree roots:	None 0%	Embeddedness:	Fair	10
Gully erosion:	None 0%	Velocity/depth category:	Poor	5
Bank slumping:	None 0%	Channel alteration:	Poor	3
Local catchment erosion:	Little 1-10%	Bottom scouring/deposition:	Poor	3
Notes:		Pool/riffle, run/bend ratio:	Poor	3

Boggy standing pool adjacent to landholder access track and close to mining asscess track boundary. Significant cattle activity / disturbance was recorded at the site. Significant infestation of Parkinsonia (category 3 restricted invasive plant).		Bank stability:	Good	8
		Bank vegetation stability:	Good	8
		Streamside dominant cover:	Good	8
		Total score:	Fair	53

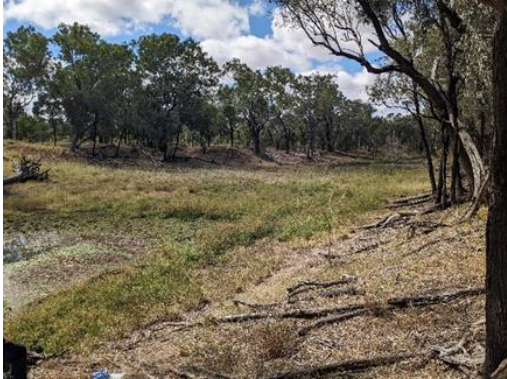
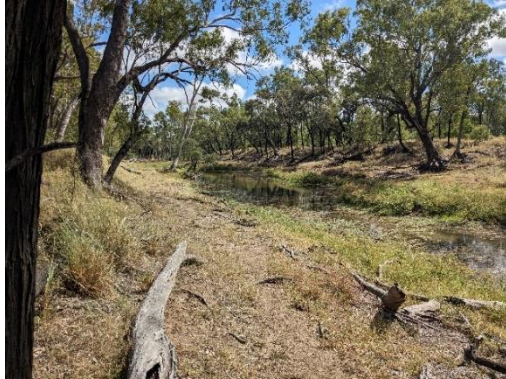
## Monitoring site MP6 (Receiving)

Water flow:	standing	Water oils:	None	
Pool dimensions (m):	150 x 15 m	Plume:	Moderate	
Water surface:	Scum	Sediment smothering:	No	
Turbidity:	Slight	Sediment oils:	Absent	
Water colour:	Opaque	Sediment odour:	None	
Bank shape (left/right):	Concave, Concave	Adjacent land use:	Grazing, landholder track	
Bank slope (left/right):	Moderate 30-60°, Moderate 30-60°	Livestock/animal impacts:	Cattle pugging, tracks leading to the site, pig tracks	
Erosion observations		Habitat assessment: MP6		
Bare ground:	Some 10-50%	Bottom substrate:	Poor	5
Exposed tree roots:	Some 10-50%	Embeddedness:	Poor	5
Gully erosion:	Some 10-50%	Velocity/depth category:	Poor	5
Bank slumping:	Little 1-10%	Channel alteration:	Poor	3
Local catchment erosion:	Some 10-50%	Bottom scouring/deposition:	Fair	7

Notes:		Pool/riffle, run/bend ratio:	Poor	3
Section of the Mackenzie River anabranch located near landholder access track and fence line. Cattle access is apparent and pig tracks were spotted at the site, and further along the creek. The pool was standing water and contained significant macrophytes.		Bank stability:	Fair	5
		Bank vegetation stability:	Fair	5
		Streamside dominant cover:	Fair	5
		Total score:	Fair	43
