# JELLINBAH COAL MINE RECEIVING ENVIRONMENT MONITORING PROGRAM

## 2024 PROGRESS REPORT

PREPARED FOR  
JELLINBAH MINING PTY LTD

19 July 2024

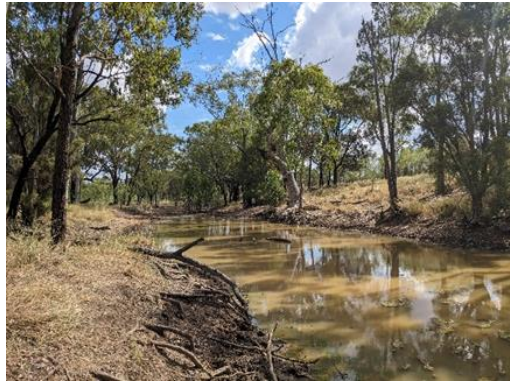
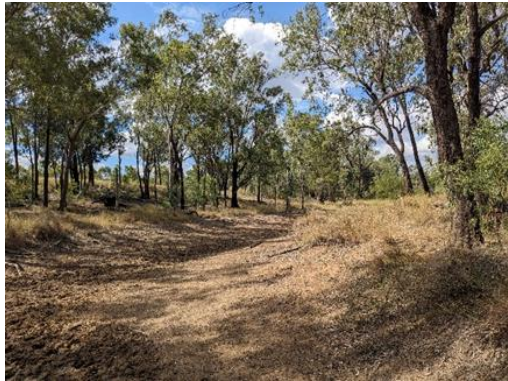
Water flow:	Standing	Water oils:	None	
Pool dimensions (m):	100 x 10 m	Plume:	Moderate	
Water surface:	Scum	Sediment smothering:	No	
Turbidity:	Opaque	Sediment oils:	Absent	
Water colour:	Opaque	Sediment odour:	None	
Bank shape (left/right):	Concave, Concave	Adjacent land use:	Grazing	
Bank slope (left/right):	Low 10-30°, Low 10-30°,	Livestock/animal impacts:	Cattle pugging and cattle at the site, no pig activity detected	
Erosion observations		Habitat assessment: MP7		
Bare ground:	Some 10-50%	Bottom substrate:	Poor	5
Exposed tree roots:	Some 10-50%	Embeddedness:	Poor	5
Gully erosion:	Some 10-50%	Velocity/depth category:	Poor	5
Bank slumping:	None 0%	Channel alteration:	Poor	3
Local catchment erosion:	Some 10-50%	Bottom scouring/deposition:	Fair	7
Notes:		Pool/riffle, run/bend ratio:	Poor	3

Section of the anabranch, located near the Mackenzie River and upstream of MP6. Cattle evidence was significant; however, no pig activity was detected at the site. Clearing of vegetation was slight, and many mature trees remain, however the understorey is dominated by non-native grasses.		Bank stability:	Good	8
		Bank vegetation stability:	Fair	5
		Streamside dominant cover:	Fair	5
		Total score:	Fair	46

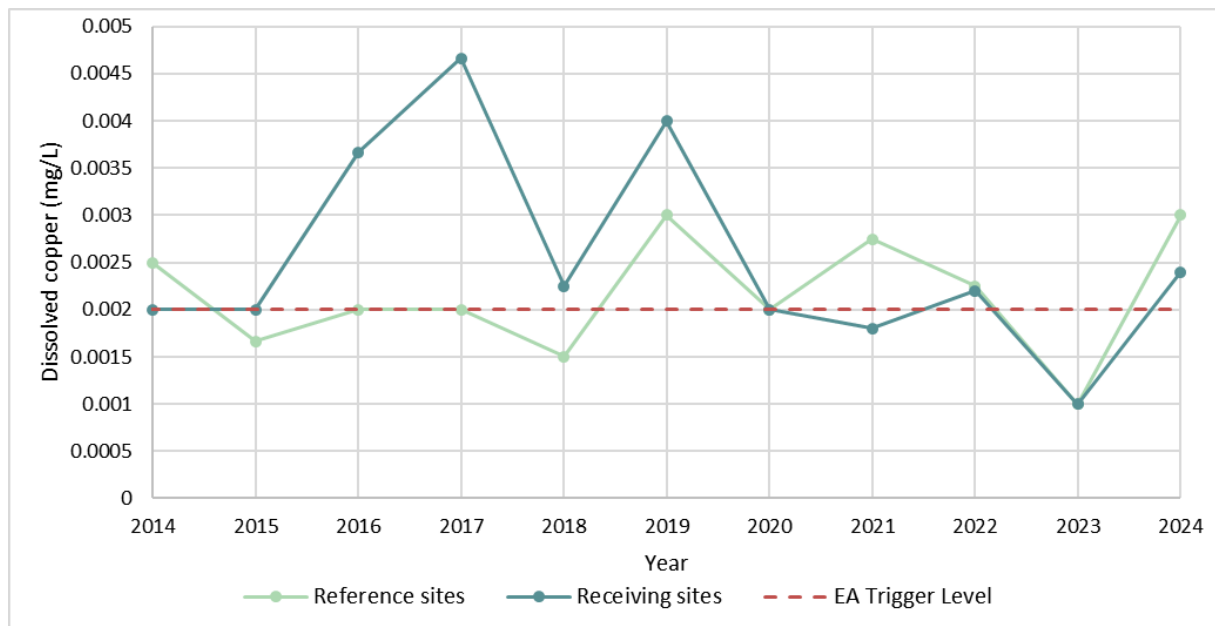
Figure F-1: Time series of dissolved copper concentrations in surface water

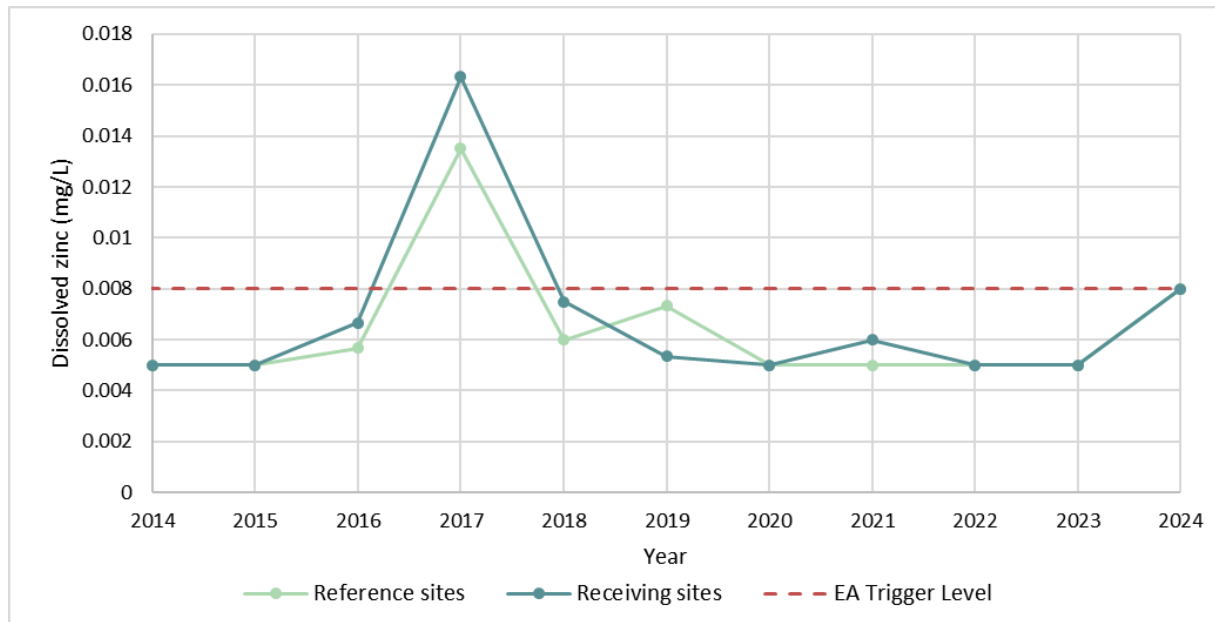
Figure F-2: Time series of dissolved zinc concentrations in surface water

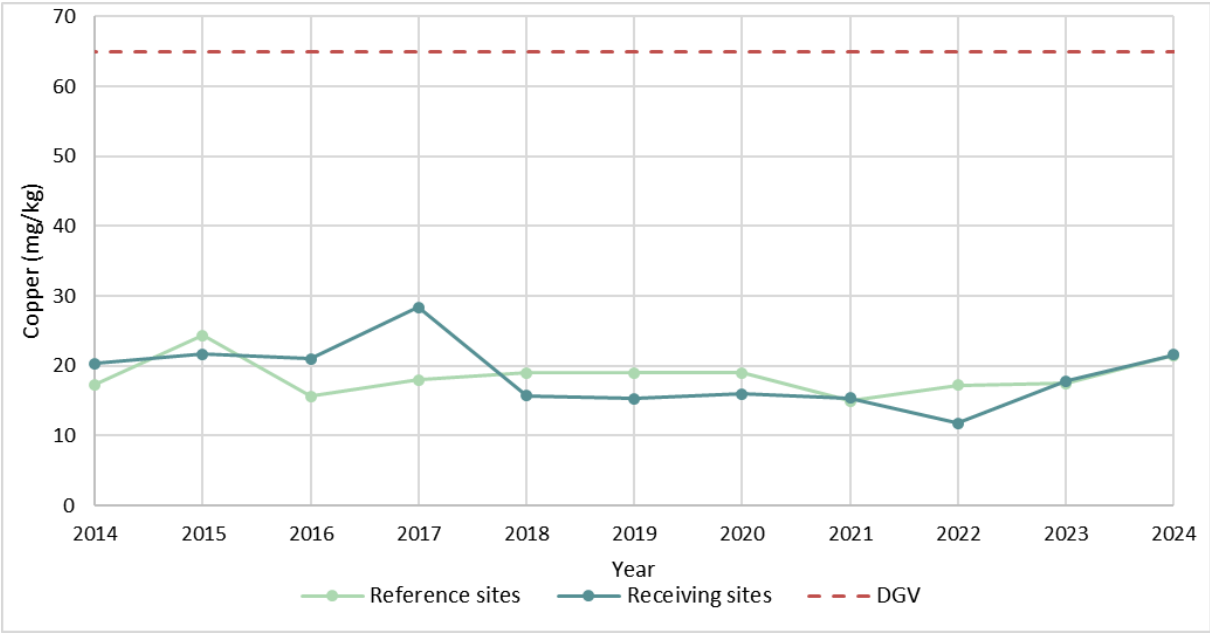
Figure F-3: Time series of dissolved copper concentrations in stream sediment

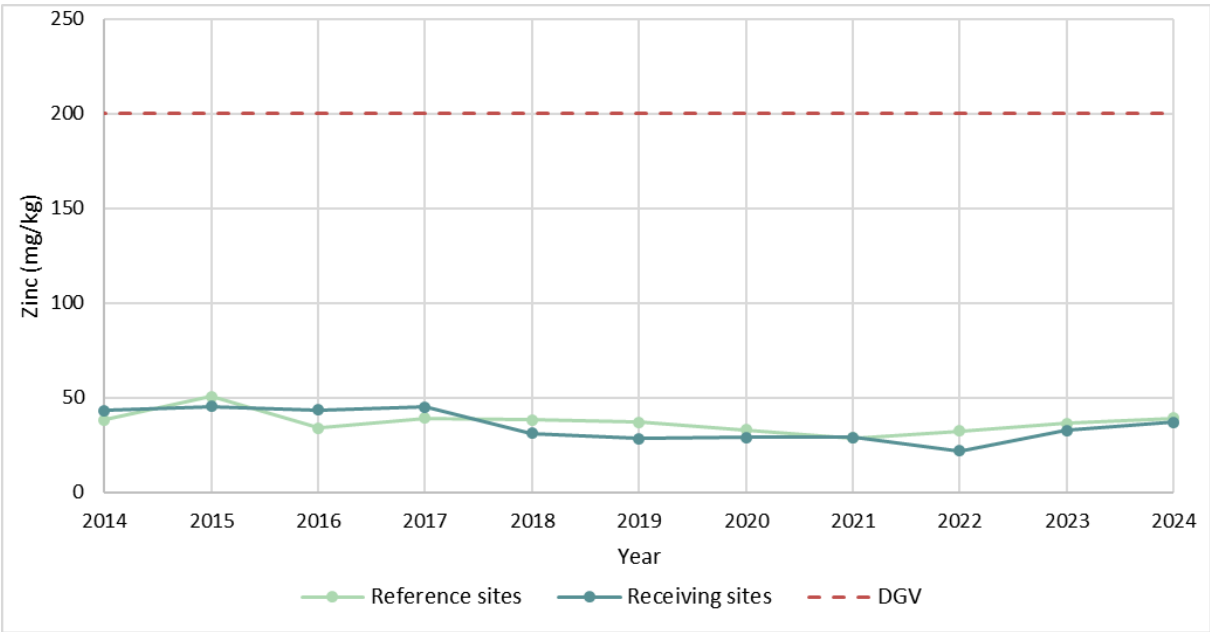
Figure F-3: Time series of dissolved zinc concentrations in stream sediment
